**Van:** [redacted]@odrn.nl>  
**Verzonden:** 21-04-2021 16:51  
**Aan:** [redacted]@odrn.nl>  
**CC:** [redacted]@inspectieszw.nl>  
**Onderwerp:** FW: meldingen asbestverwijdering RK1 (Hollandiaweg 11)

**Release form, visual inspection risk class 1 asbestos removal****General data**

| Description of work area: | Asbestos Removal area 1 and separation between FGD and Precips. |

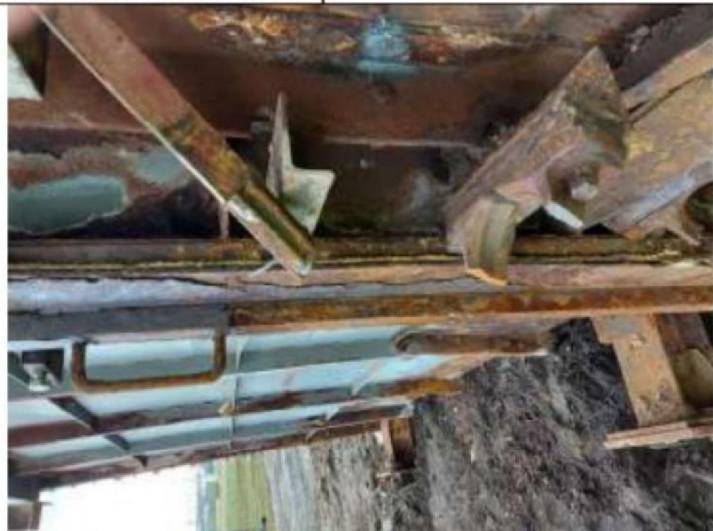
Description photo: 26-3-2021 parts off separation between FGD and Precips. This parts includes textile bandage which has to be separated.

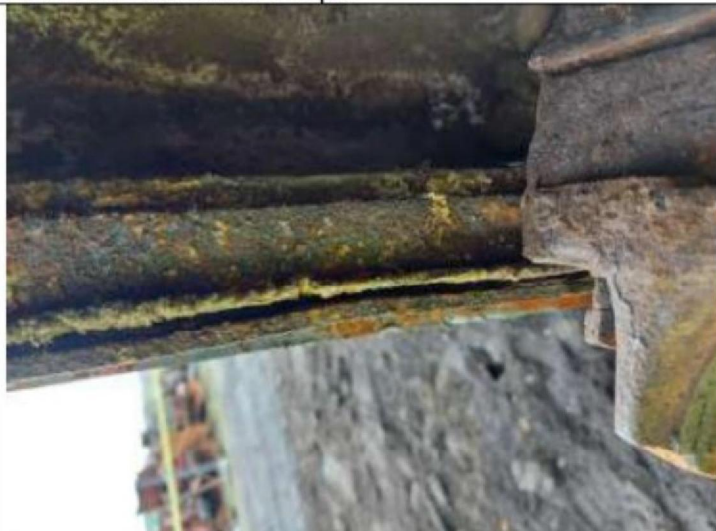
Description photo: 26-3-2021 parts off separation between FGD and Precips. This parts includes textile bandage which has to be separated.

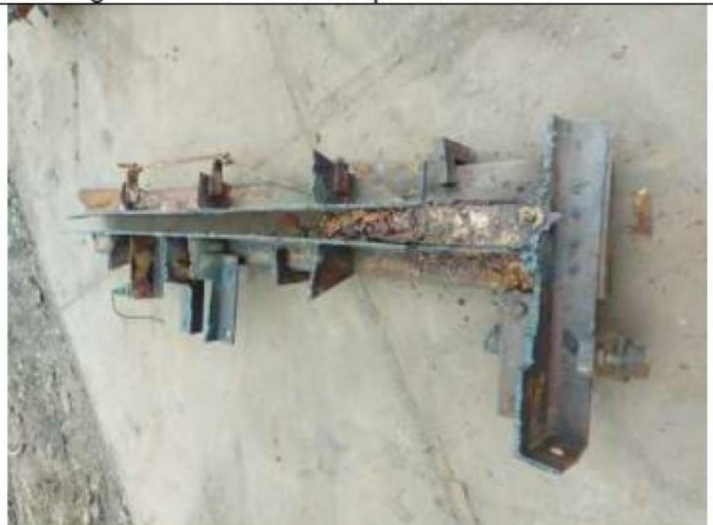
Description photo: 26-3-2021 parts off separation between FGD and Precips. This parts includes textile bandage which has been separated in RC 1. After separation is has been put in the skip which has been provided with a containerbag with A-vignette.

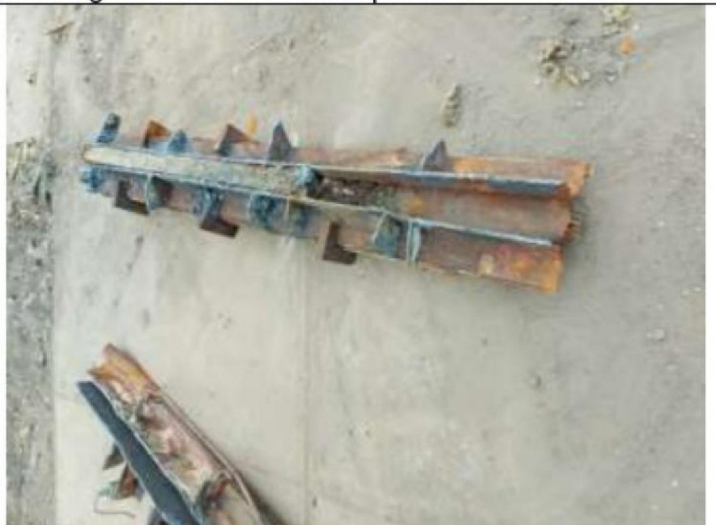
Description photo: 26-3-2021 parts off separation between FGD and Precips. This parts includes textile bandage which has been separated in RC 1. After separation is has been put in the skip which has been provided with a containerbag with A-vignette.
