REPORT: Site Review & Inspection

08.10.2016

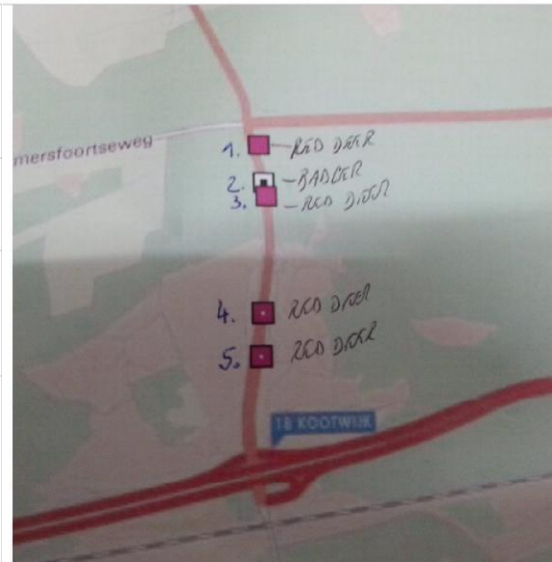
All sections with accidents have been examined (see picture below).

case 1

Left side: 3 units missing

Right side: 1 device not working

case 2 / case 3

left side: 1 device knocked down, 1 device not working

right side: 3 devices missing, 1 not working

case 4

Road-section with wide green median strip

case 5

Left side: 2 devices missing

Summary N302: There is a clear connection between missing / non-working devices. Missing and non-working devices have to be replaced that full protection is achieved.

Remark: This section should be protected with additional devices to increase the protection
