**Van:** [redacted]@odrn.nl>  
**Verzonden:** 21-04-2021 16:51  
**Aan:** [redacted]@odrn.nl>  
**CC:** [redacted]@inspectieszw.nl>  
**Onderwerp:** FW: meldingen asbestverwijdering RK1 (Hollandiaweg 11)

**Release form, visual inspection risk class 1 asbestos removal****General data**

| Description of work area: | Asbestos Removal area 1 and separation between FGD and Precips. |

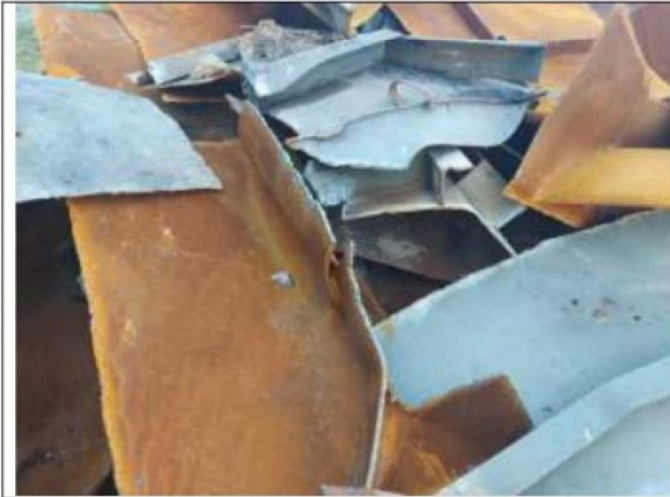
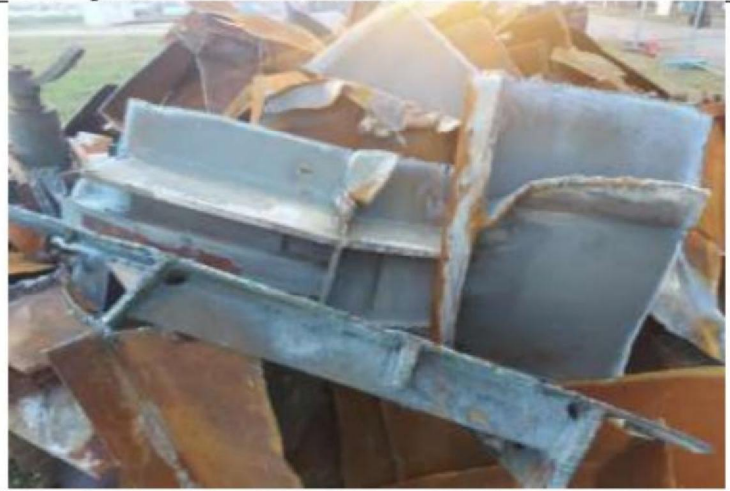
Description photo: 26-2-2021 metal pieces outside the fencing after removal asbestos

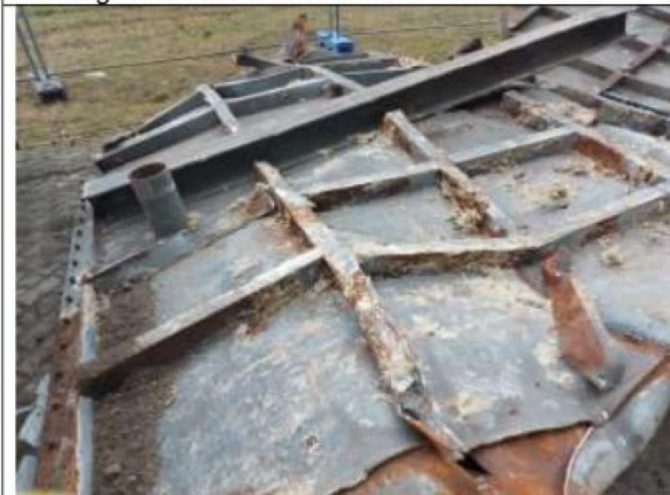
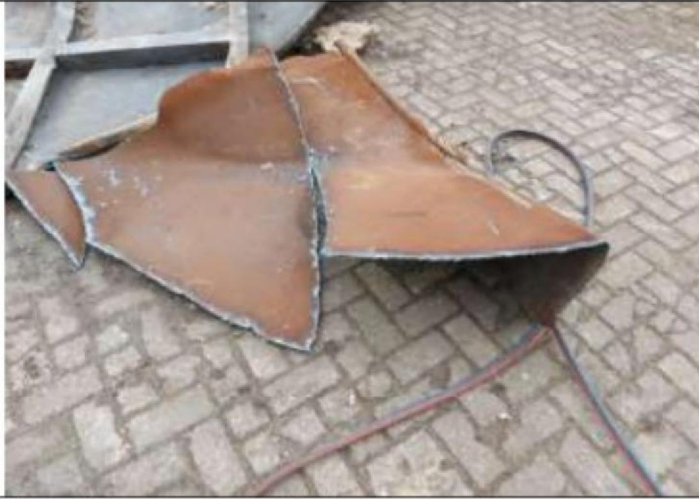
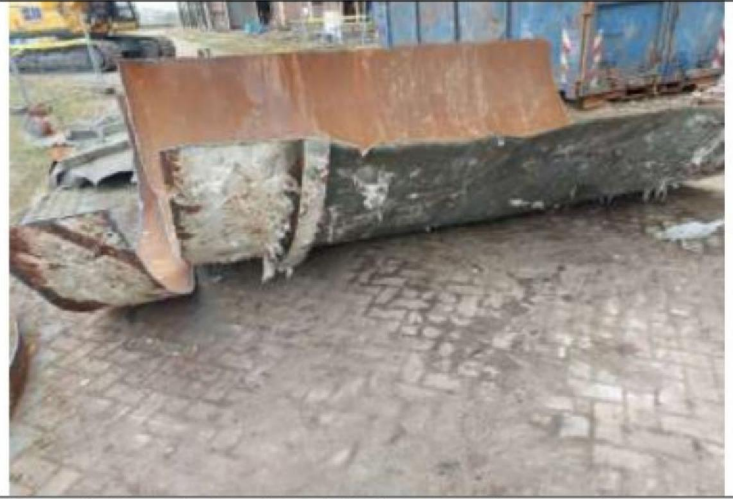
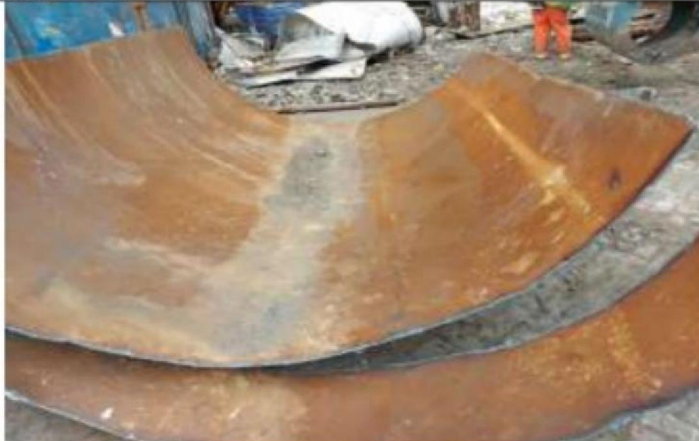
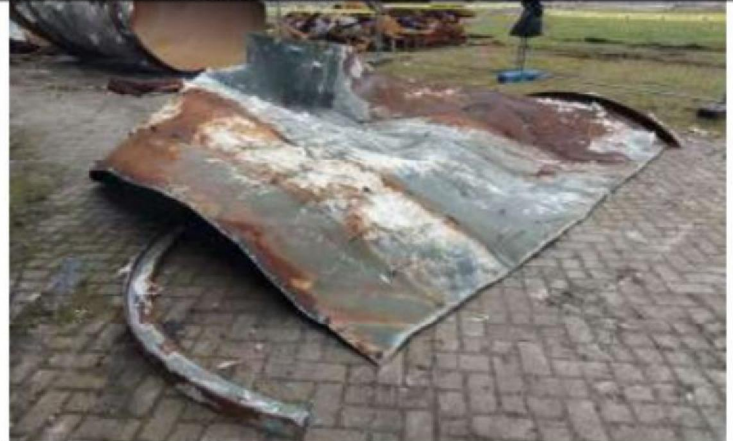
Description photo: 10-3-2021 parts off separation between FGD and Precips

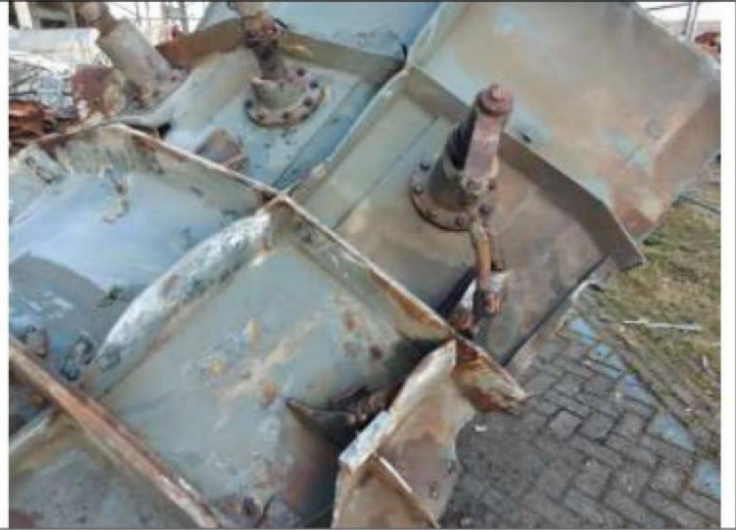
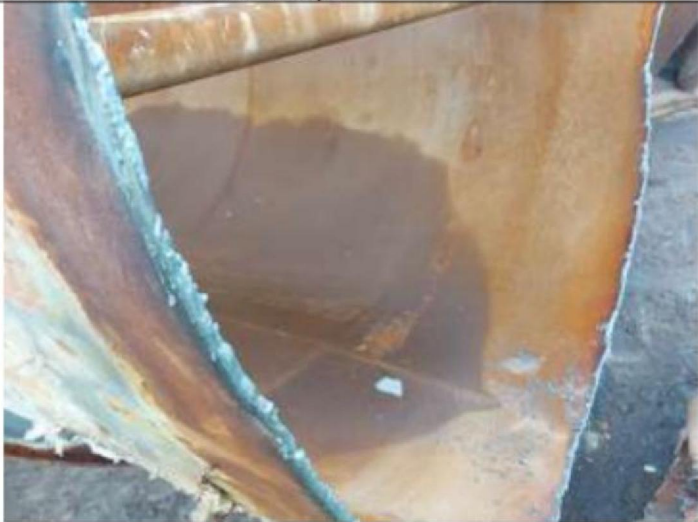
Description photo: 11-3-2021 parts off separation between FGD and Precips

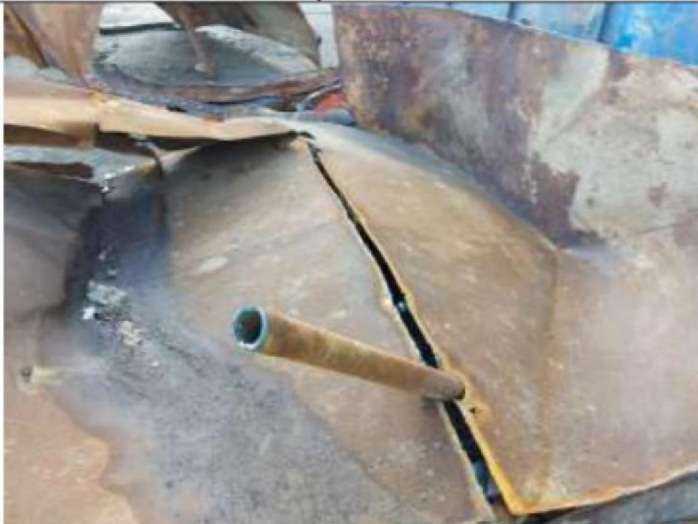
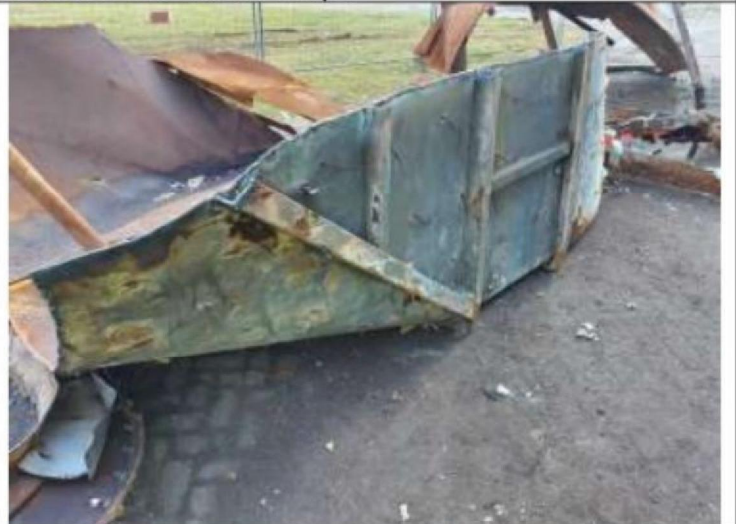
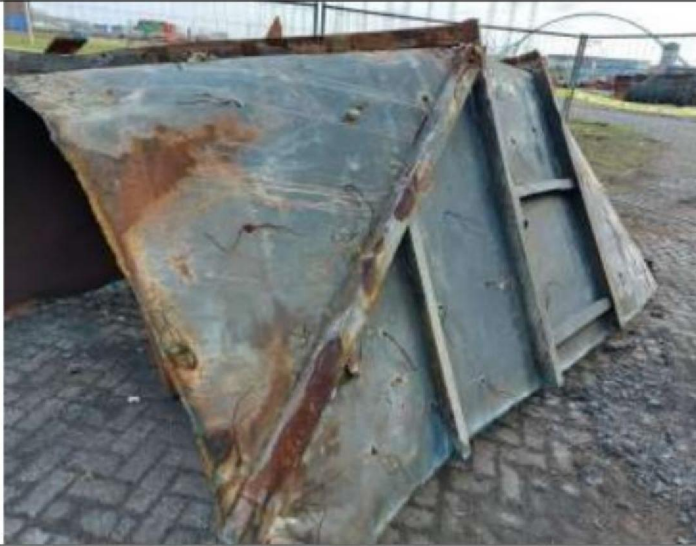
Description photo: 12-3-2021 parts off separation between FGD and Precips

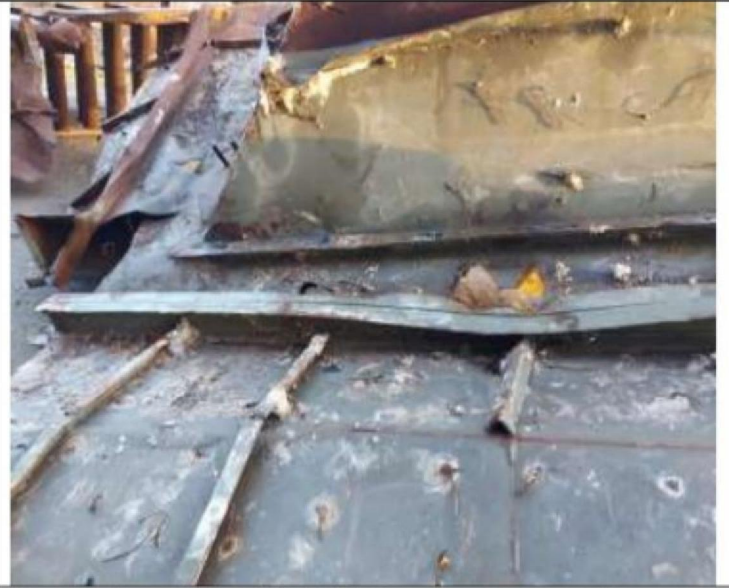
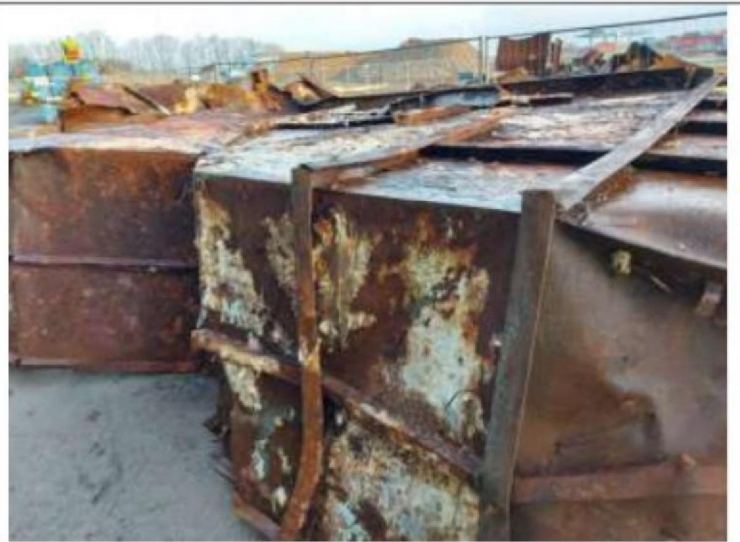
Description photo: 15-3-2021 parts off separation between FGD and Precips

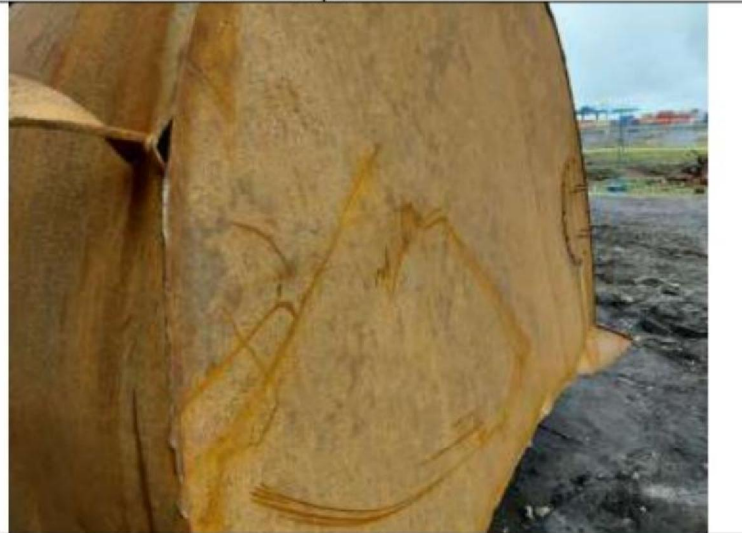
Description photo: 16-3-2021 parts off separation between FGD and Precips

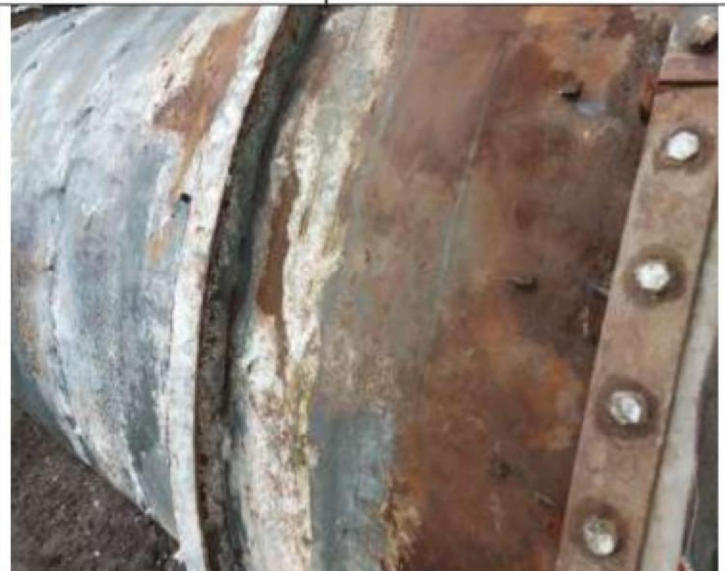
Description photo: 17-3-2021 parts off separation between FGD and Precips

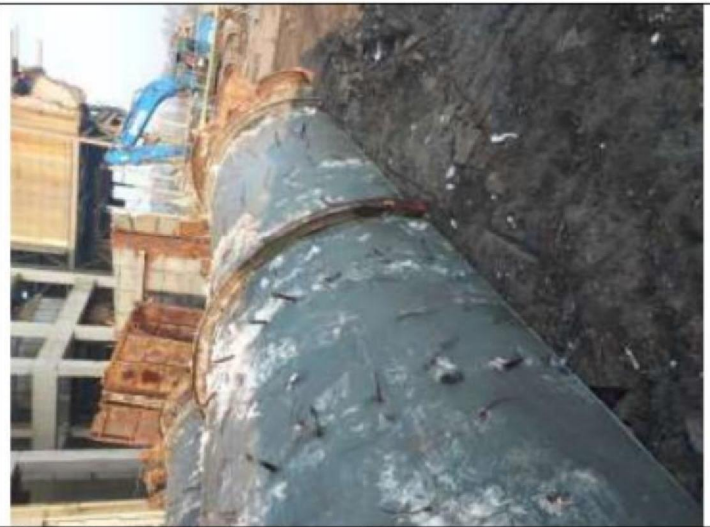
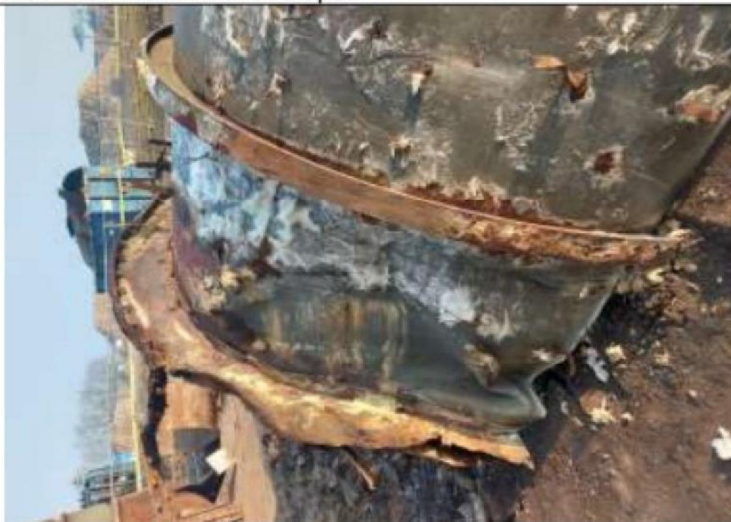
Description photo: 24-3-2021 parts off separation between FGD and Precips

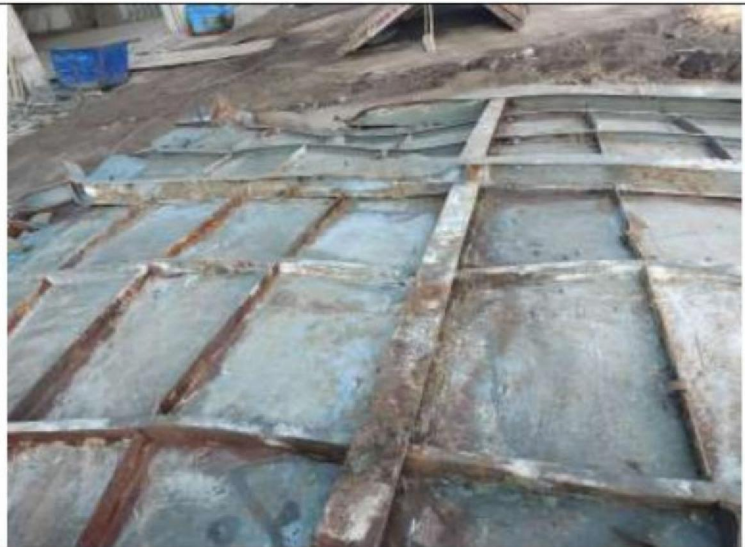
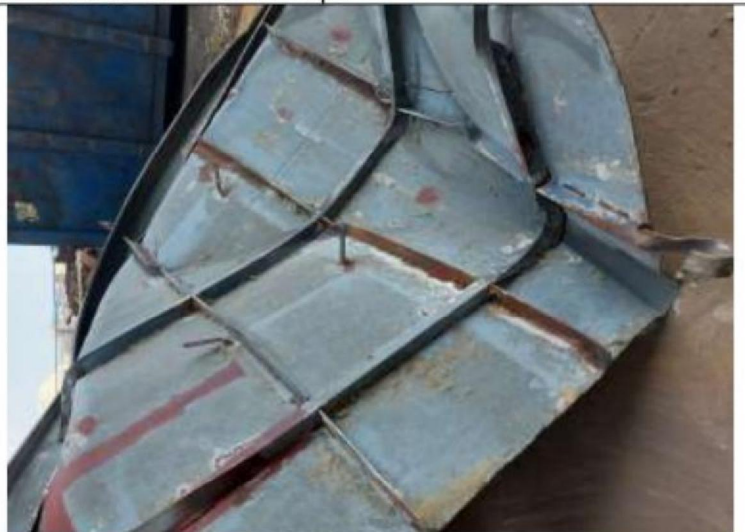
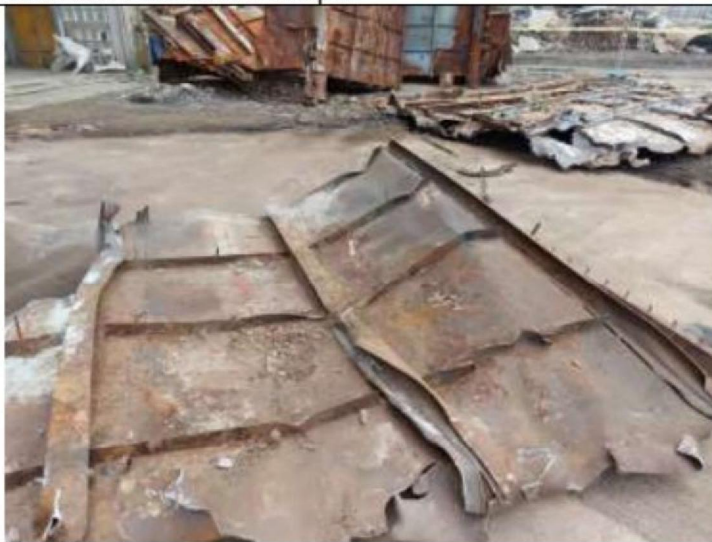
Description photo: 25-3-2021 parts off separation between FGD and Precips

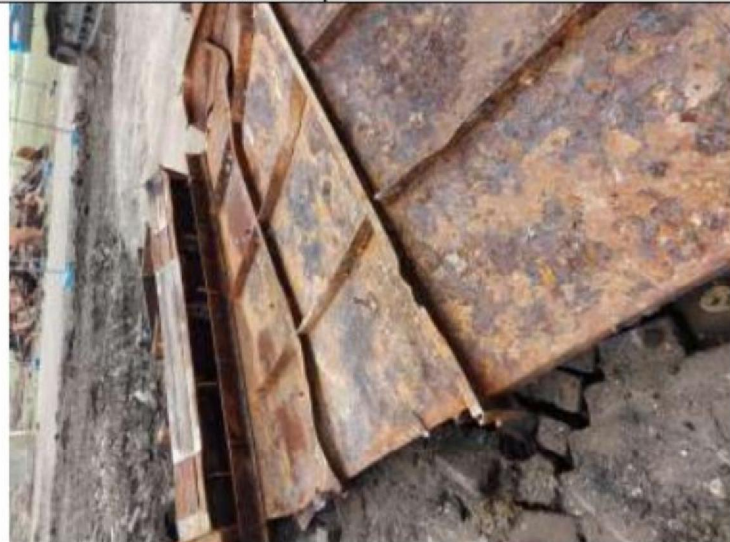
Description photo: 26-3-2021 parts off separation between FGD and Precips

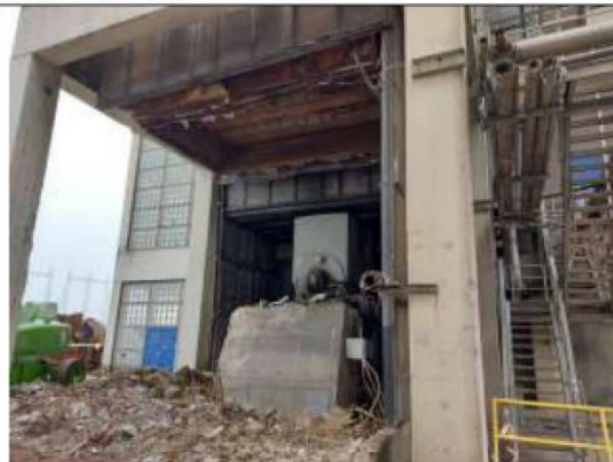
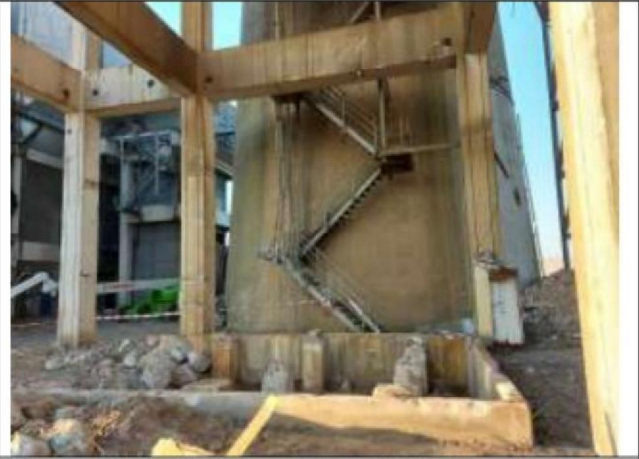
**Pictures after removal ducts and piping in the separation area**

Description photo: position ducts and piping after removal.

The parts of ducts and piping has been removed according to the MSD005. After removing we put the ducts and piping in the asbestos removal area 1. There the stamps have been removed and placed in asbestos A-vignet bags. The bags have been placed in a skip with a asbestos A-vignet containerbag.

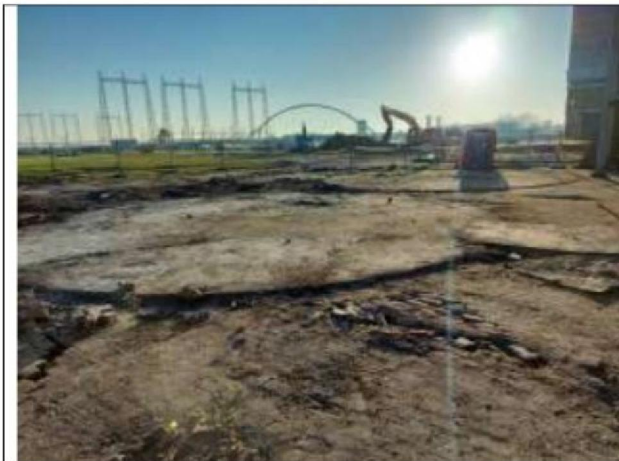
Description photo: clean concrete floor after removed the asbestos stamps and textile bandage
