**Van:** [redacted]@odrn.nl>  
**Verzonden:** 21-04-2021 16:51  
**Aan:** [redacted]@odrn.nl>  
**CC:** [redacted]@inspectieszw.nl>  
**Onderwerp:** FW: meldingen asbestverwijdering RK1 (Hollandiaweg 11)

**Release form, visual inspection risk class 1 asbestos removal****General data**

| Description of work area: | Asbestos Removal area 1 and separation between FGD and Precips. |

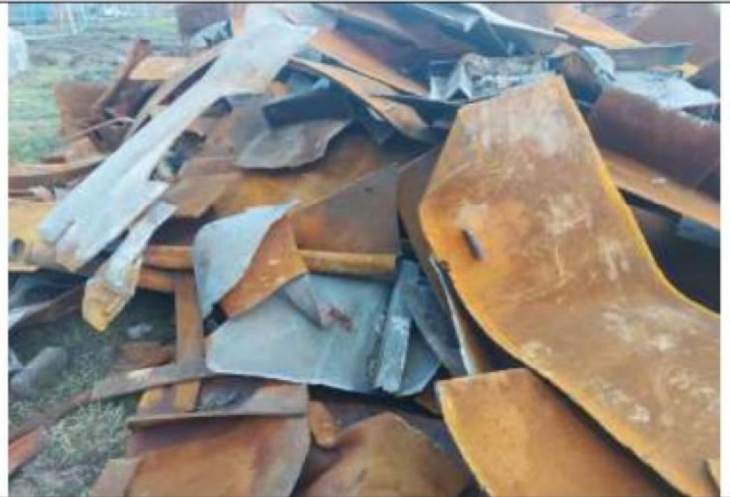
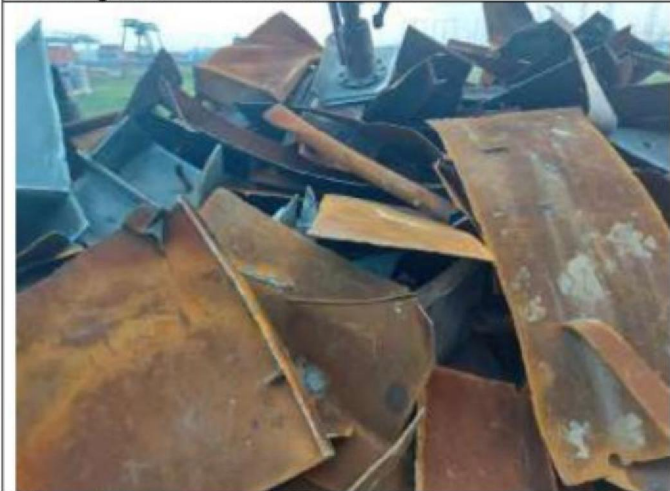
Description photo: 26-2-2021 metal pieces outside the fencing after removal asbestos

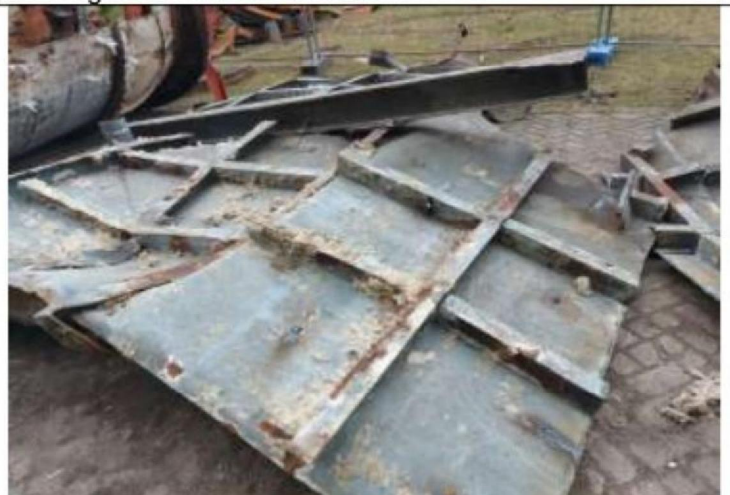
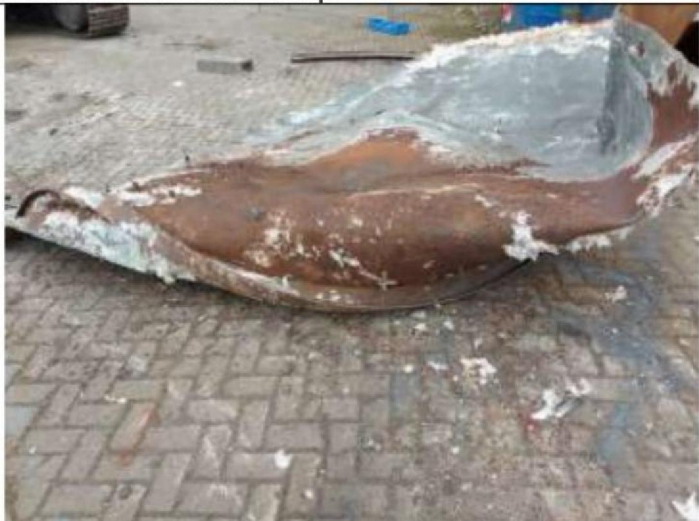
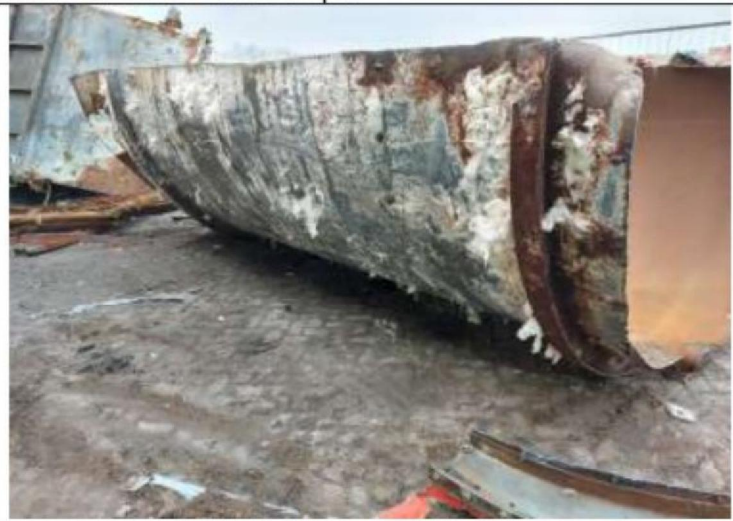
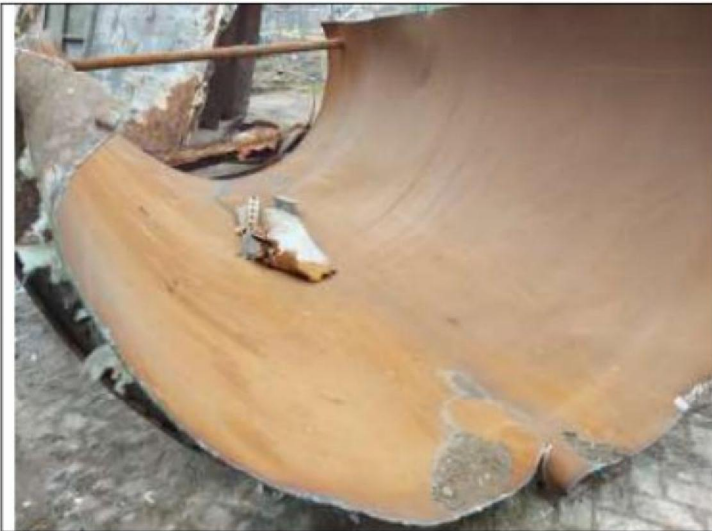
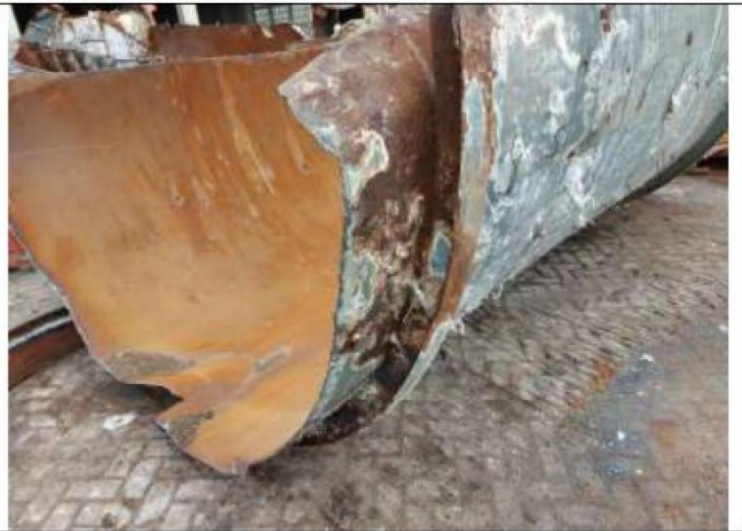
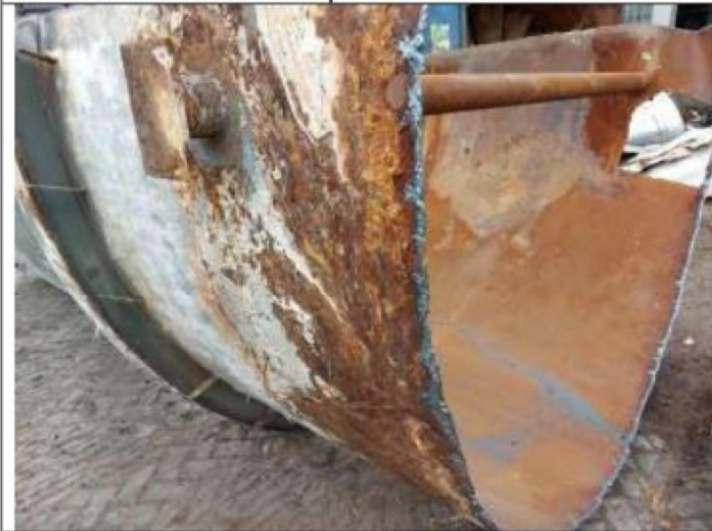
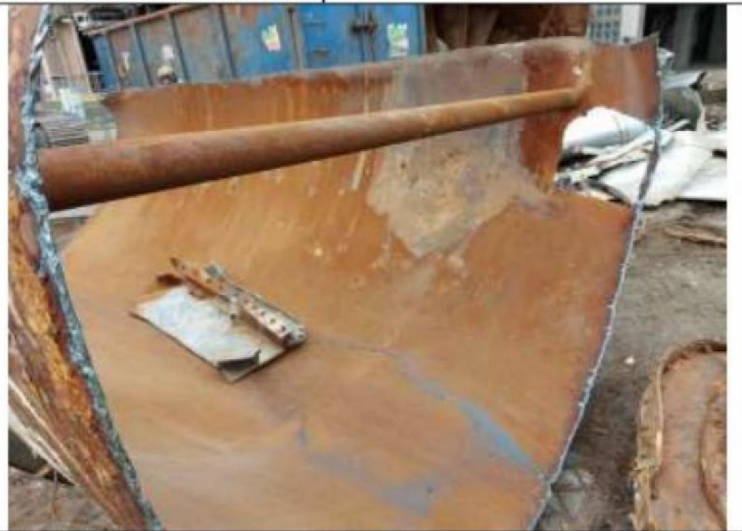
Description photo: 10-3-2021 parts off separation between FGD and Precips

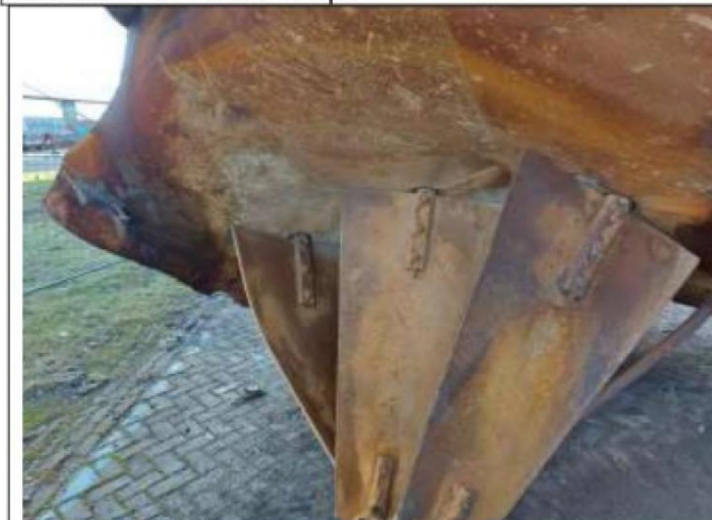
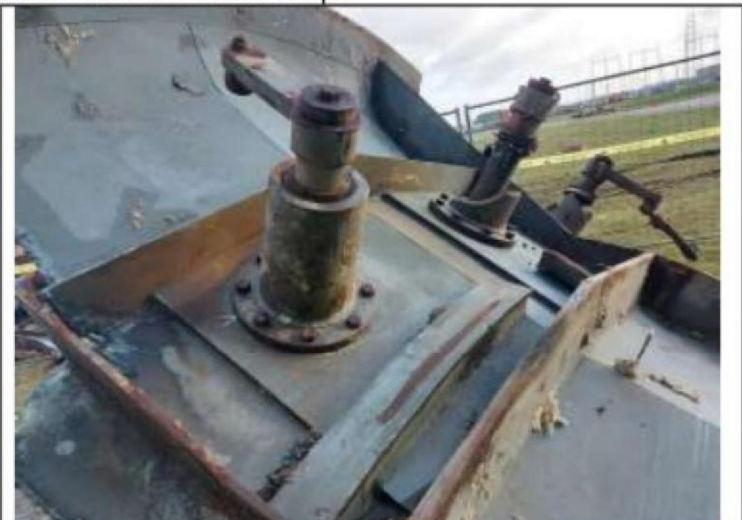
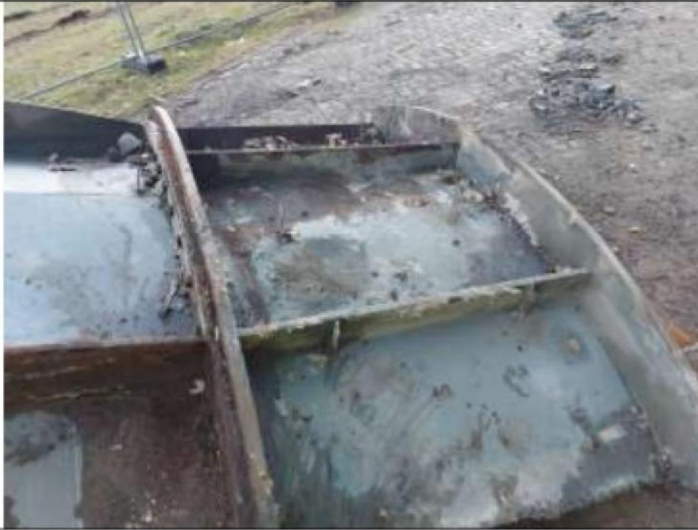
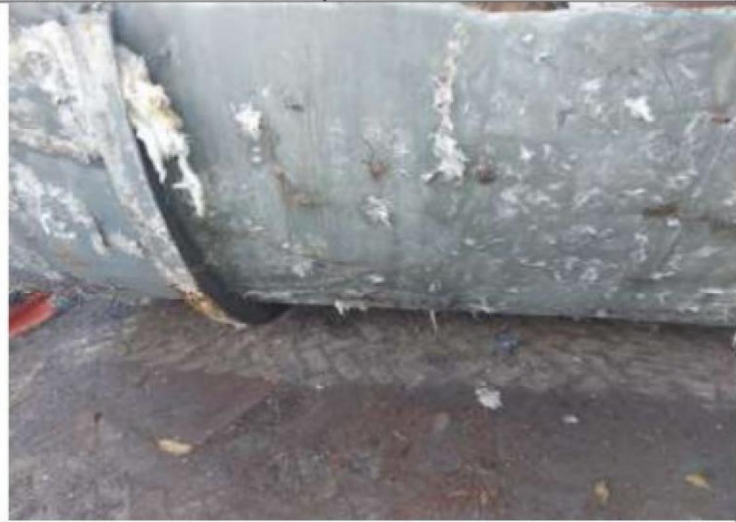
Description photo: 11-3-2021 parts off separation between FGD and Precips

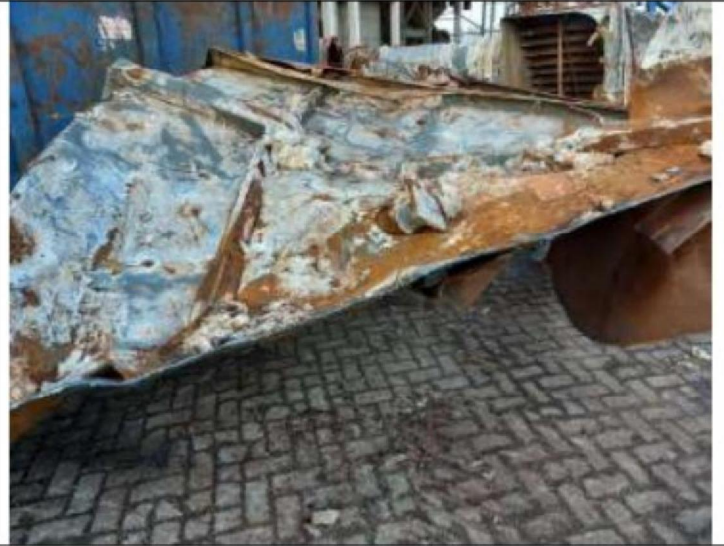
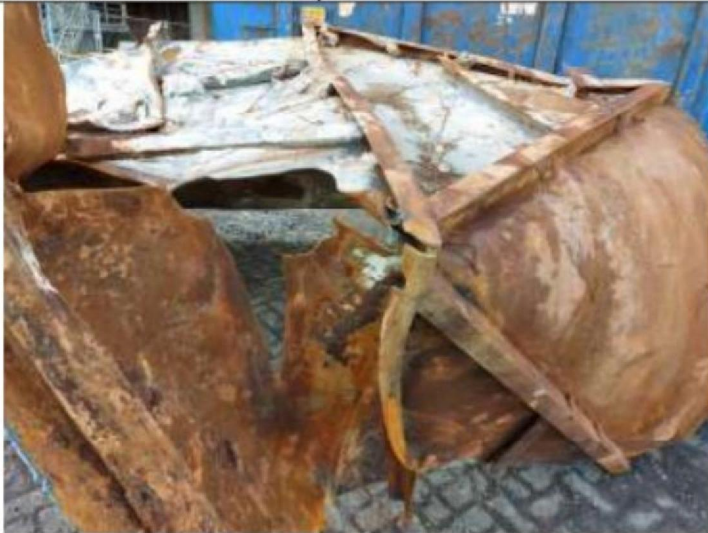
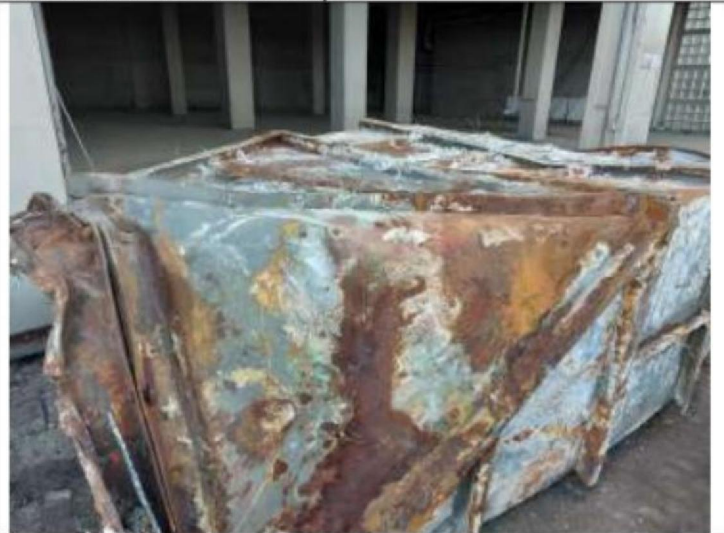
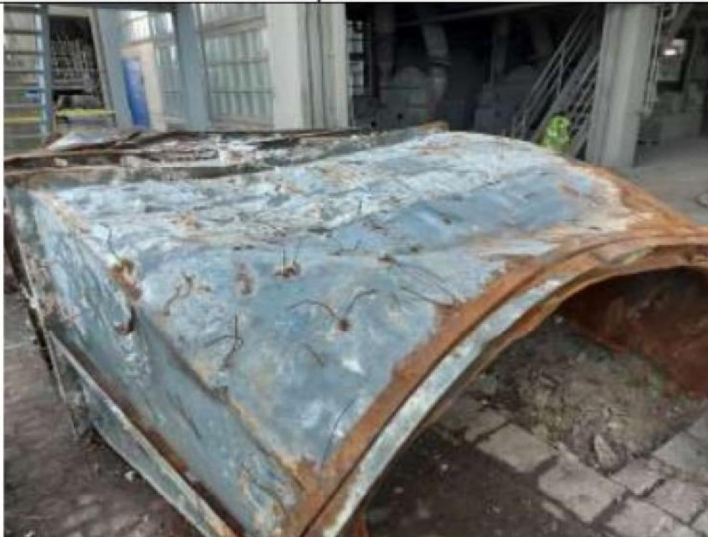
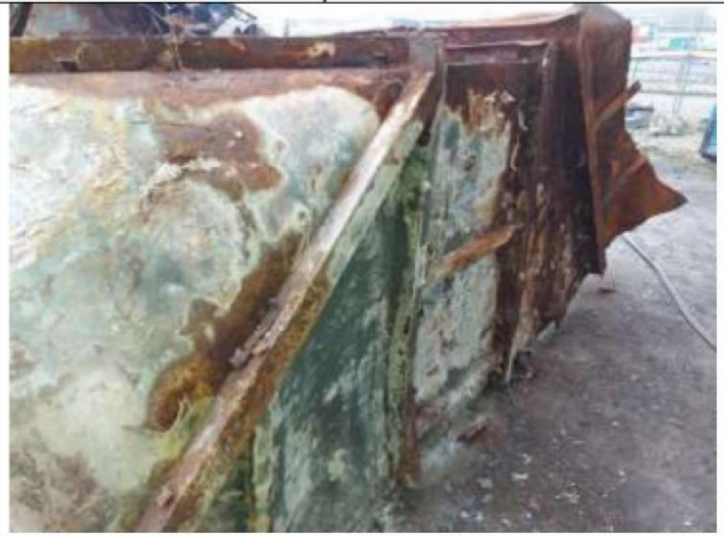
Description photo: 12-3-2021 parts off separation between FGD and Precips

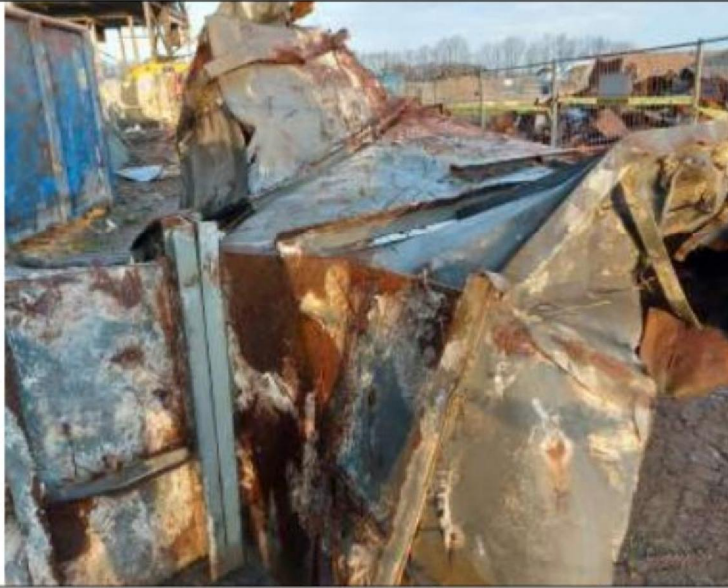
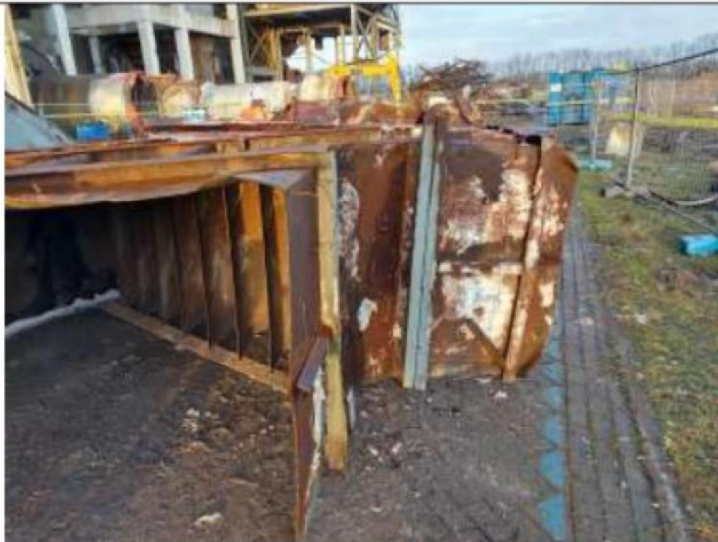
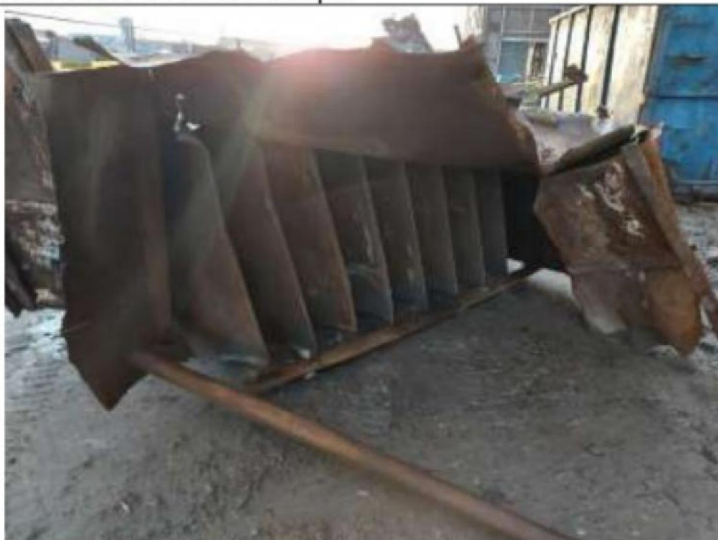
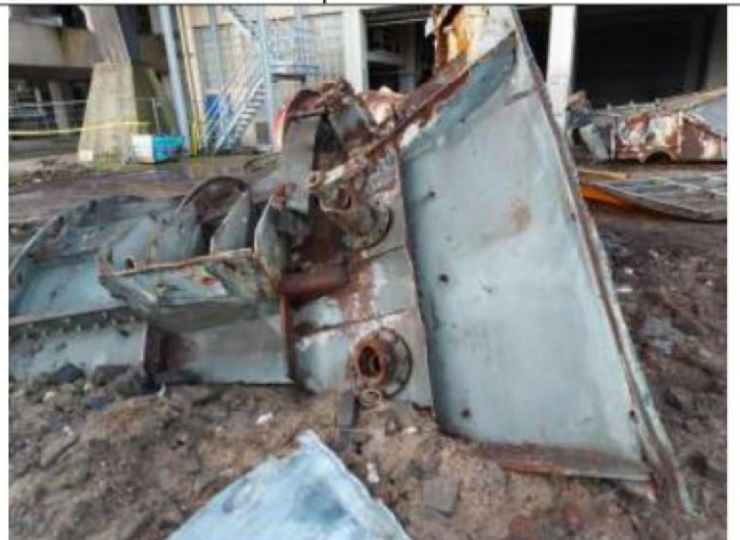
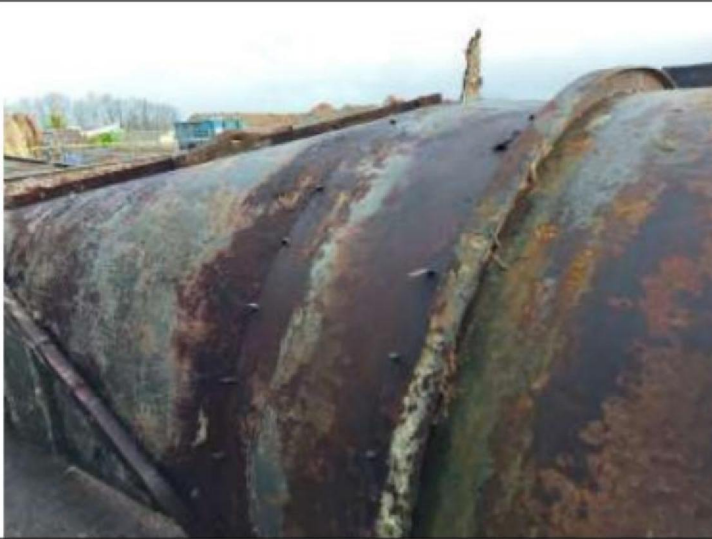
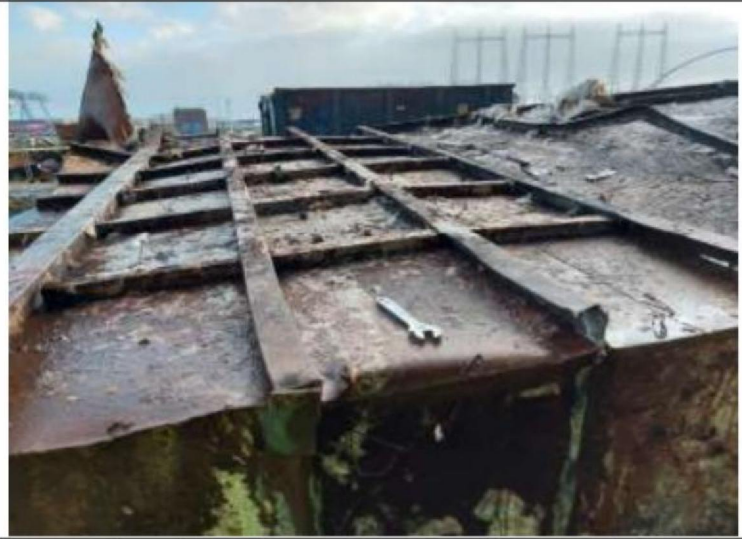
Description photo: 15-3-2021 parts off separation between FGD and Precips

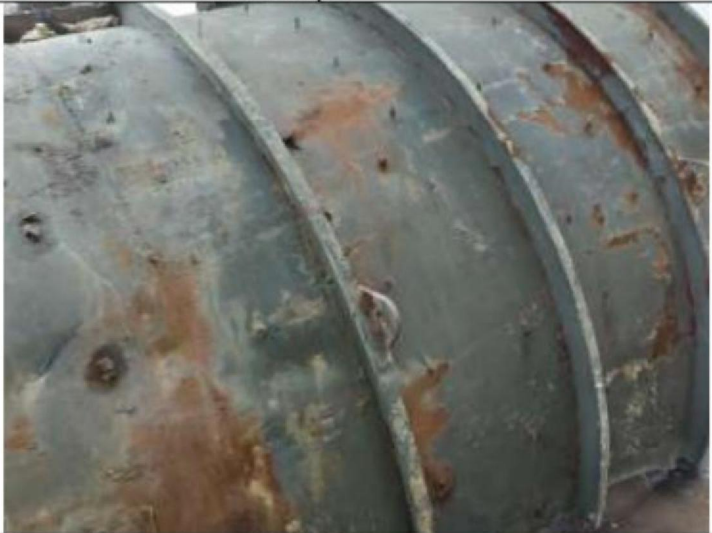
Description photo: 16-3-2021 parts off separation between FGD and Precips

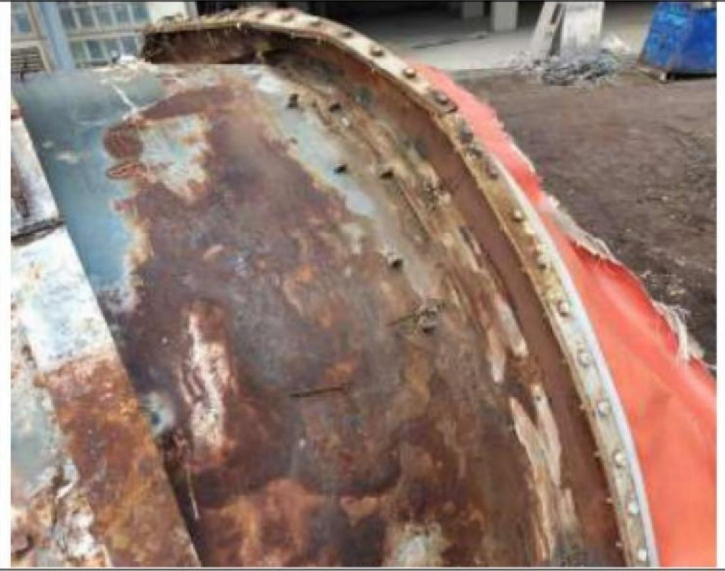
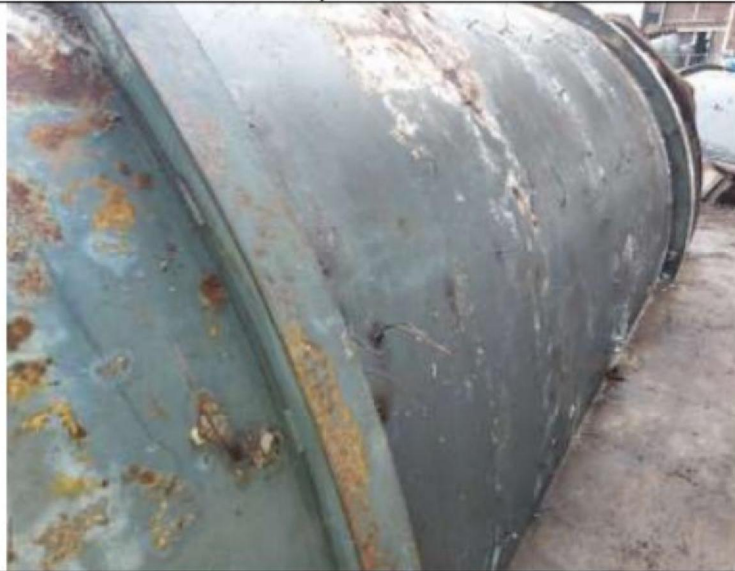
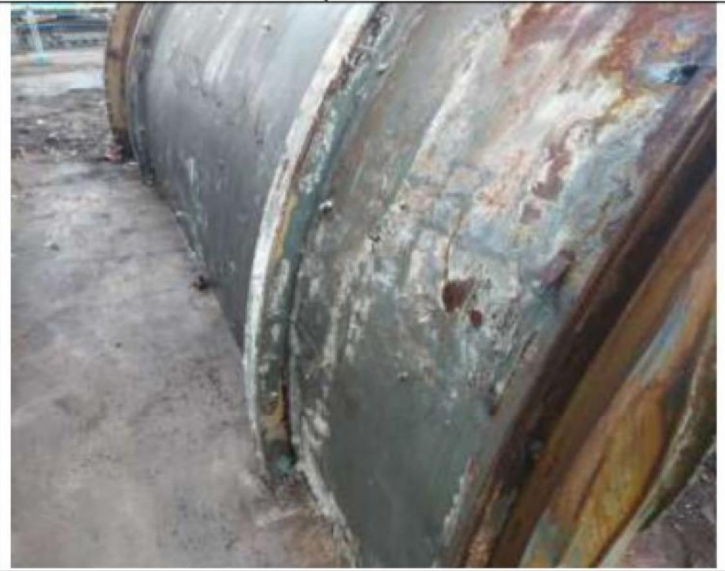
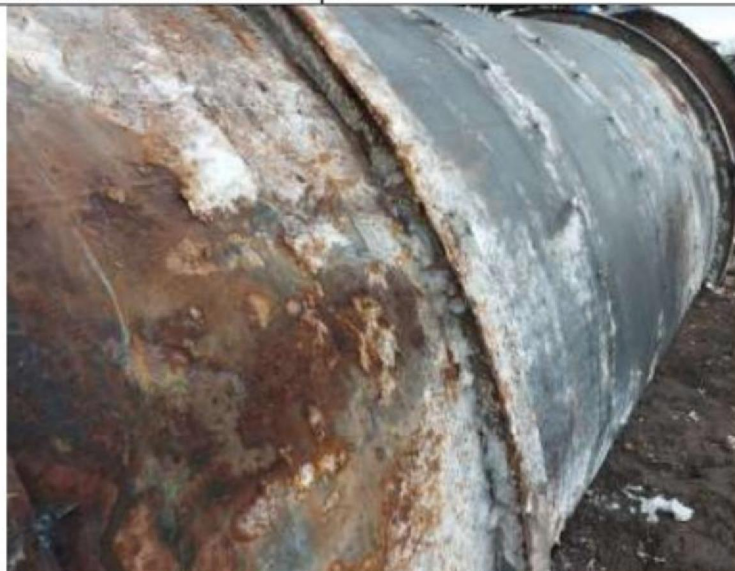
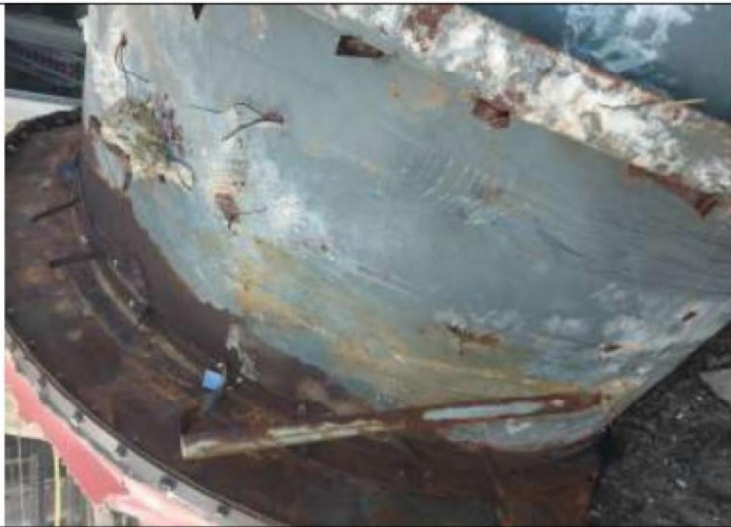
Description photo: 17-3-2021 parts off separation between FGD and Precips

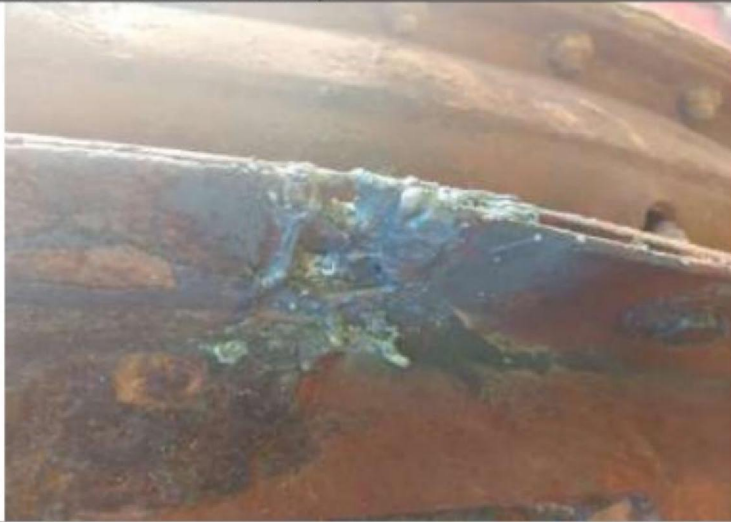
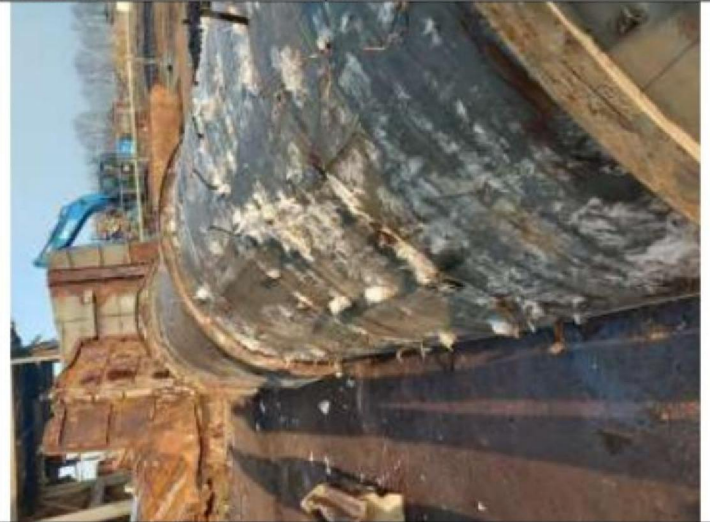
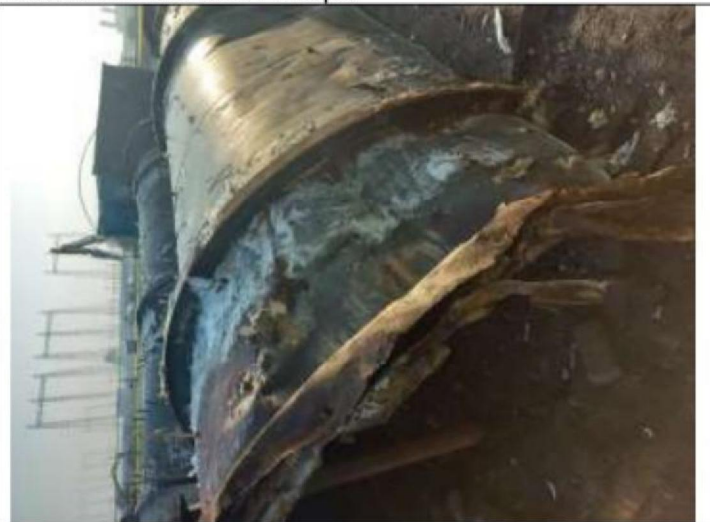
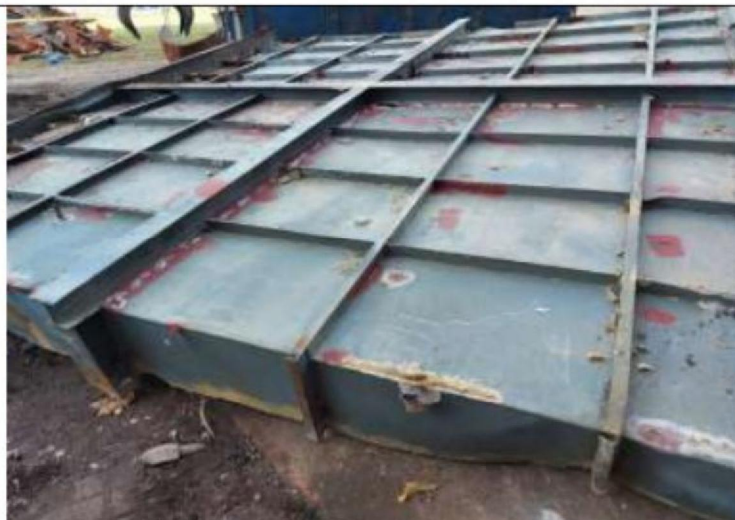
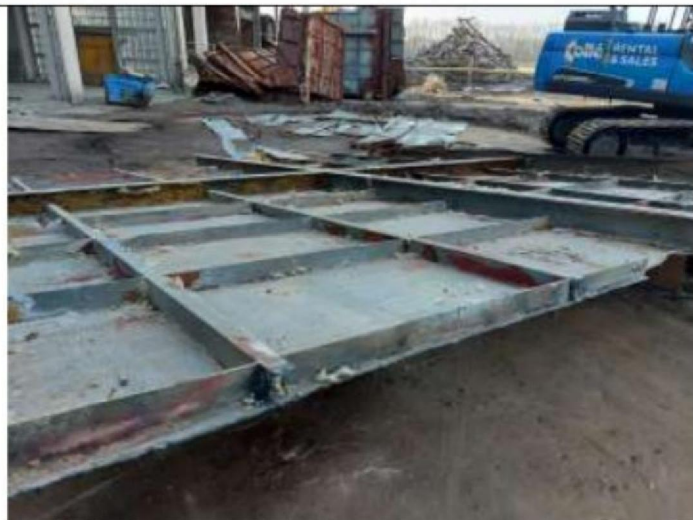
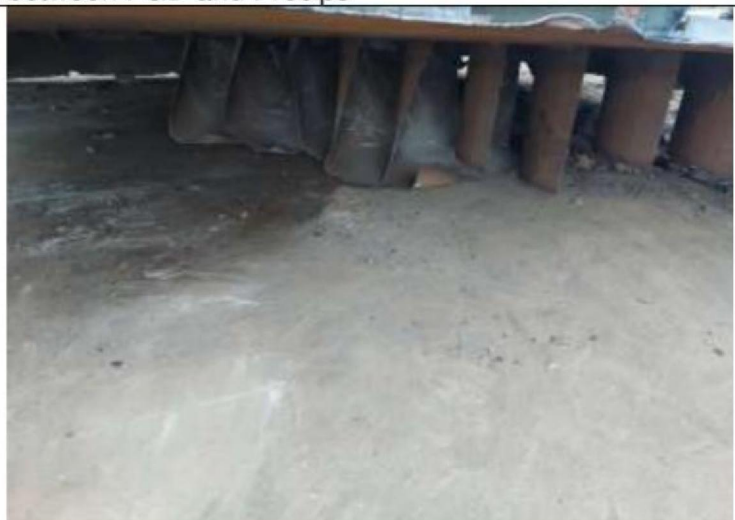
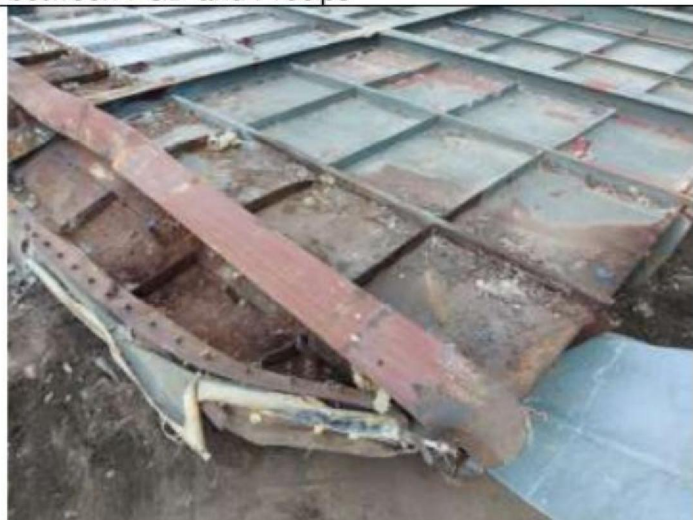
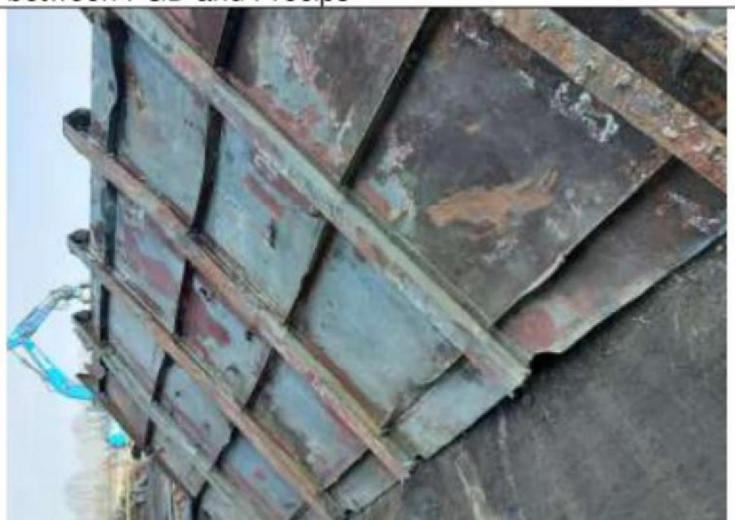
Description photo: 24-3-2021 parts off separation between FGD and Precips

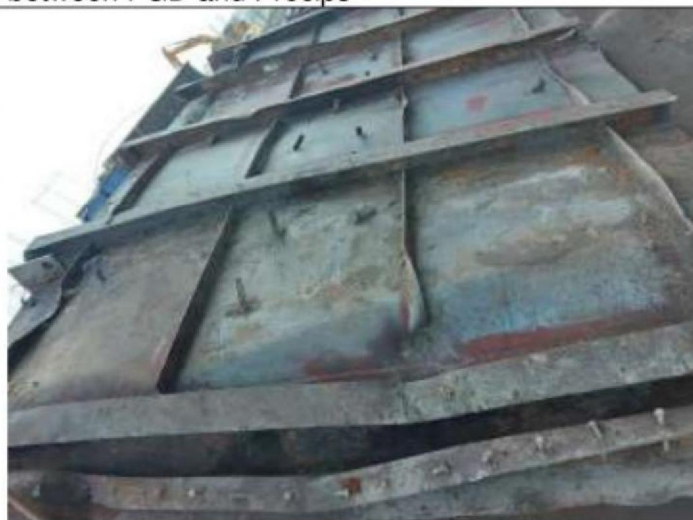
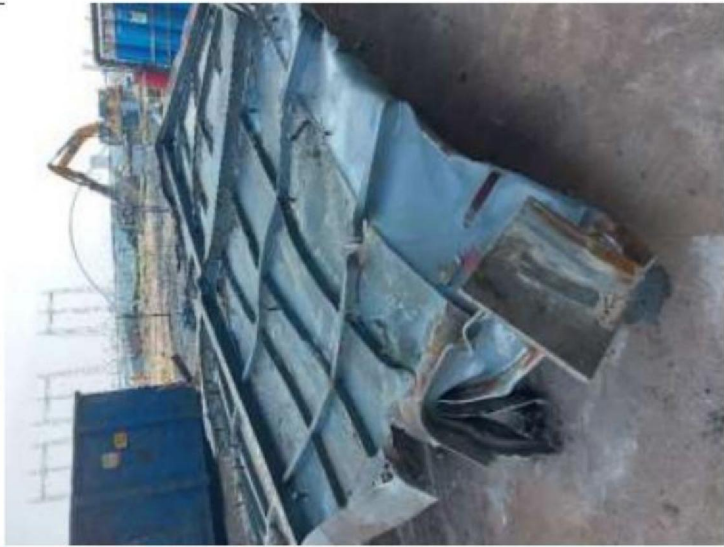
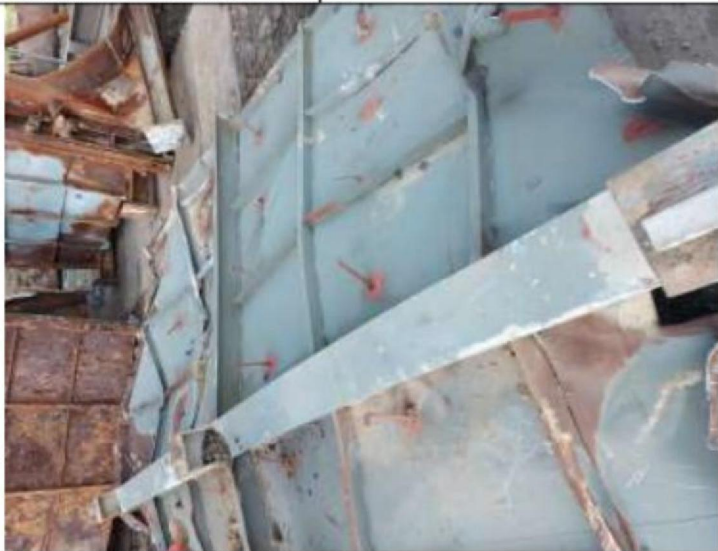
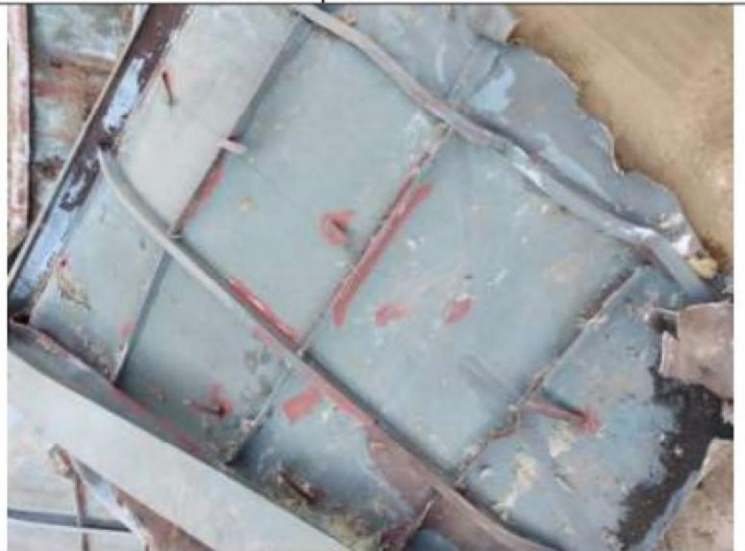
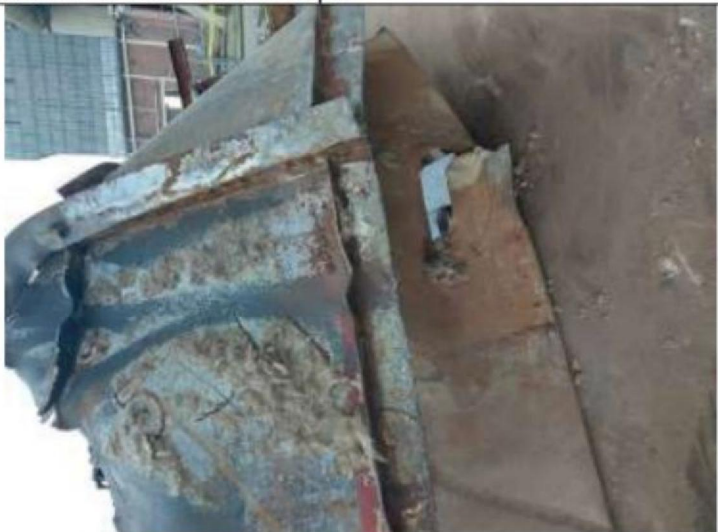
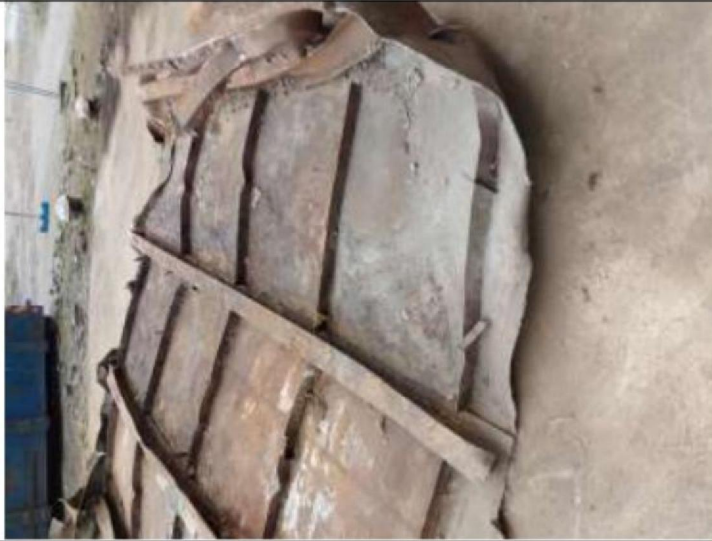
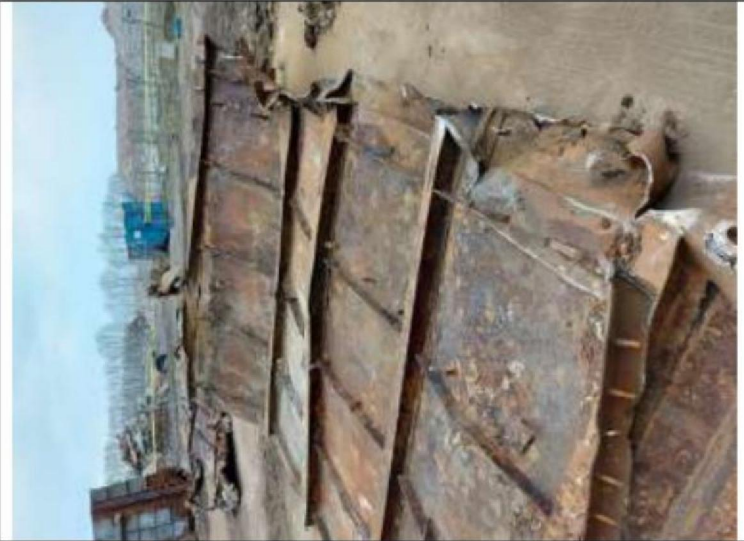
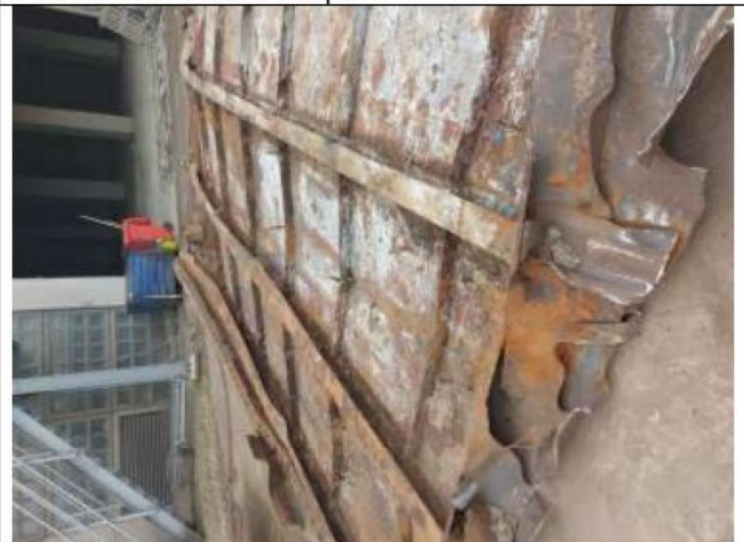
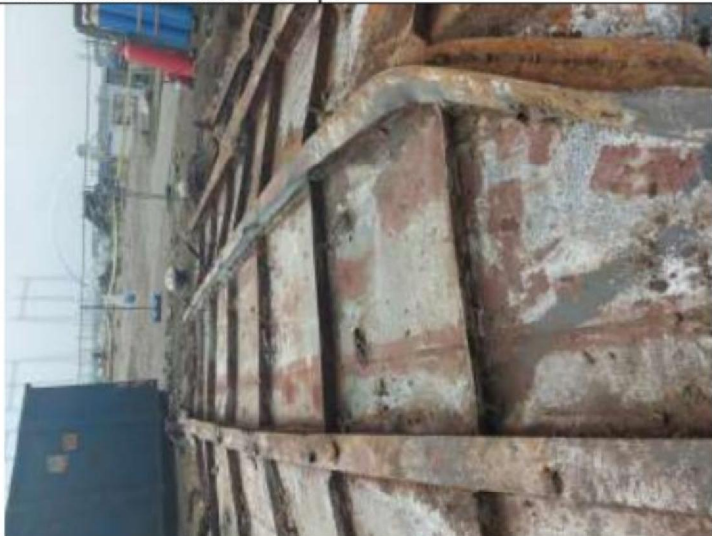
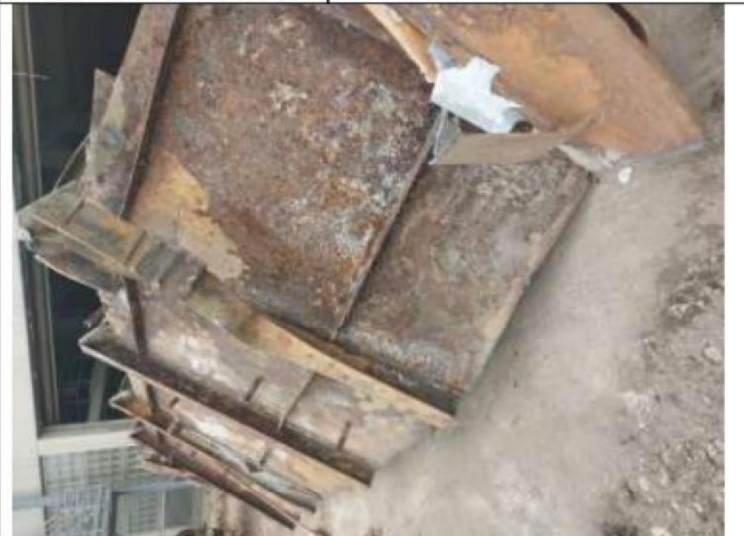
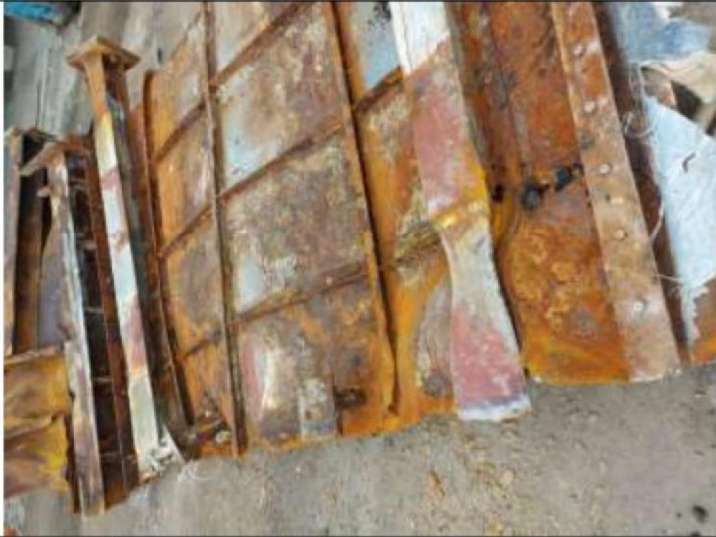
Description photo: 25-3-2021 parts off separation between FGD and Precips

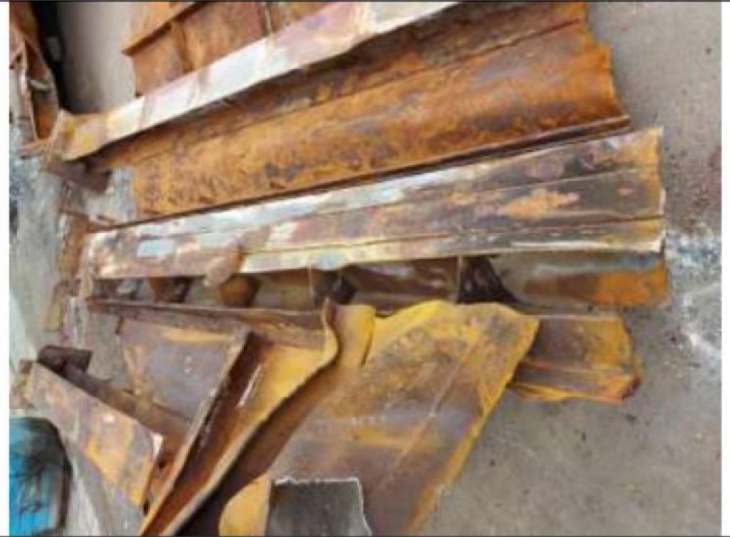
Description photo: 26-3-2021 parts off separation between FGD and Precips

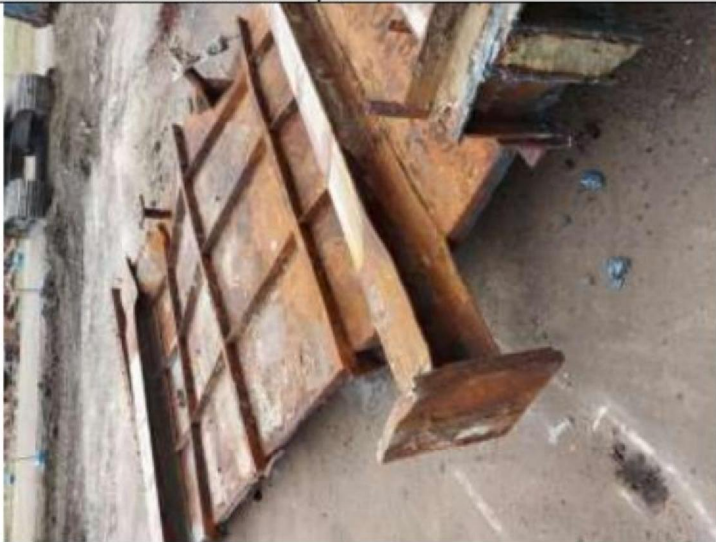
Description photo: 26-3-2021 parts off separation between FGD and Precips

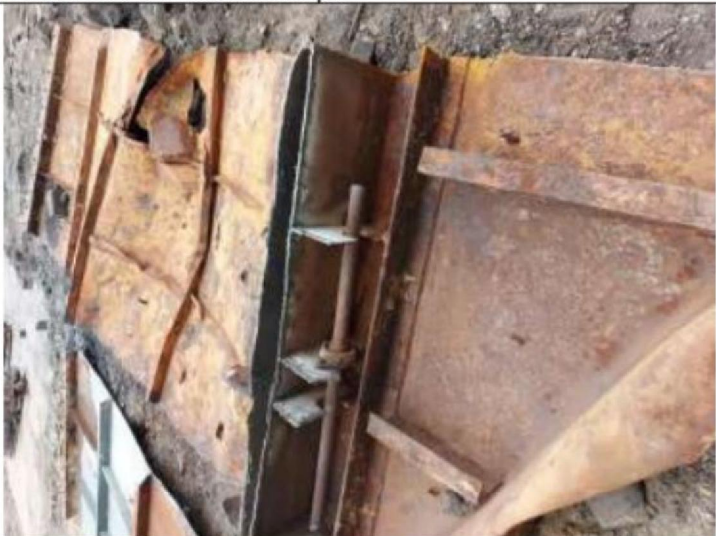
Description photo: 26-3-2021 parts off separation between FGD and Precips

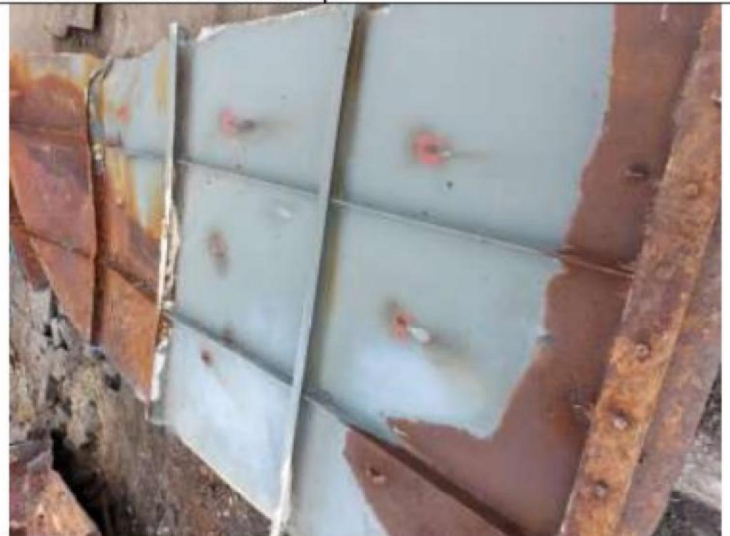
Description photo: 26-3-2021 parts off separation between FGD and Precips

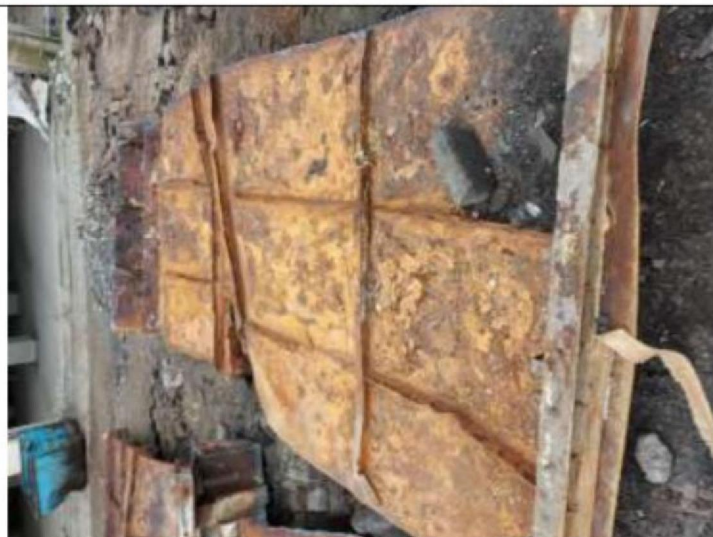
Description photo: 26-3-2021 parts off separation between FGD and Precips

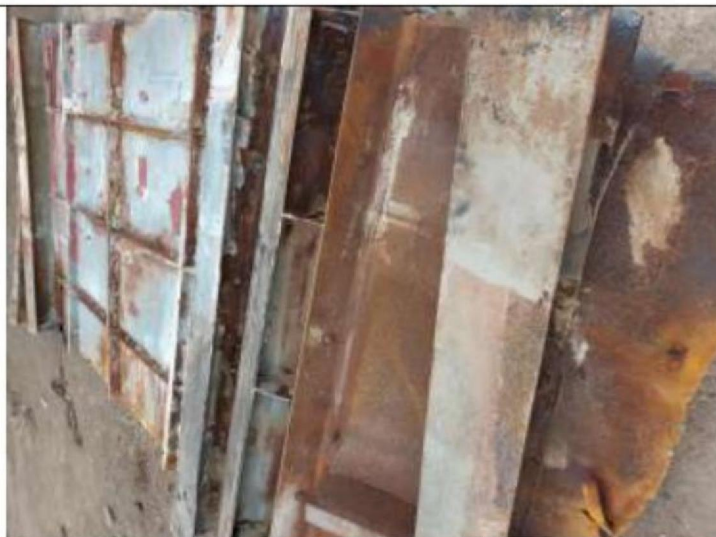
Description photo: 26-3-2021 parts off separation between FGD and Precips
