**Van:** [redacted]@odrn.nl>  
**Verzonden:** 21-04-2021 16:51  
**Aan:** [redacted]@odrn.nl>  
**CC:** [redacted]@inspectieszw.nl>  
**Onderwerp:** FW: meldingen asbestverwijdering RK1 (Hollandiaweg 11)

**Release form, visual inspection risk class 1 asbestos removal****General data**

| Description of work area: | Asbestos Removal area 1 and separation between FGD and Precips. |

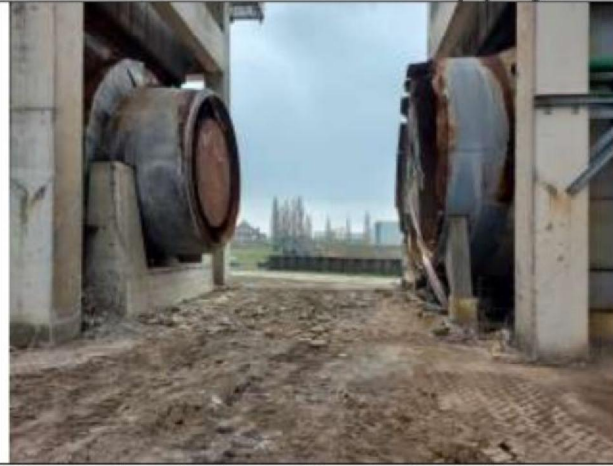
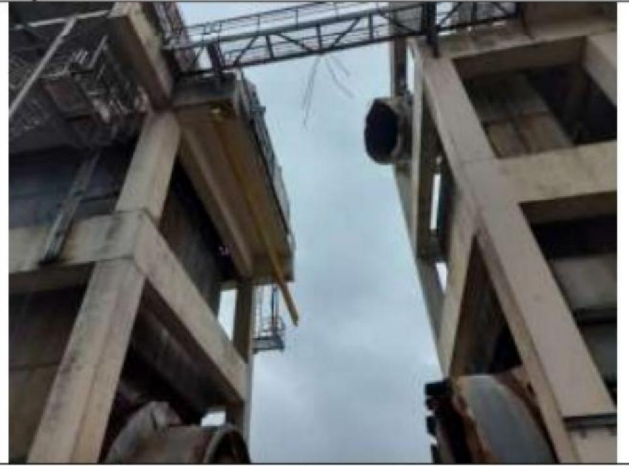
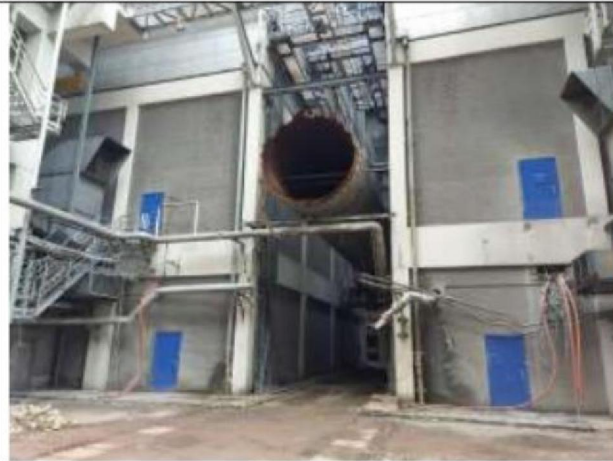
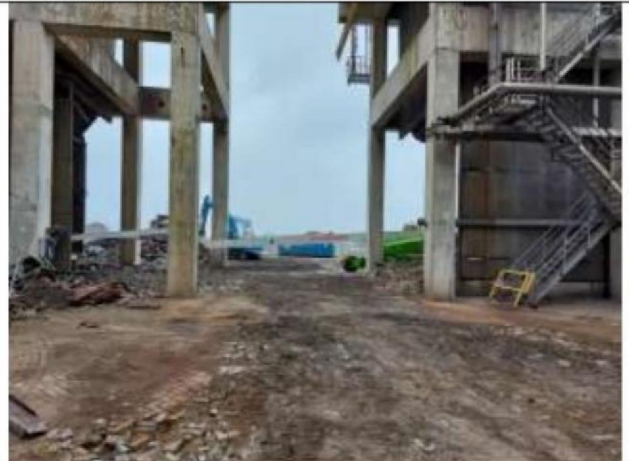
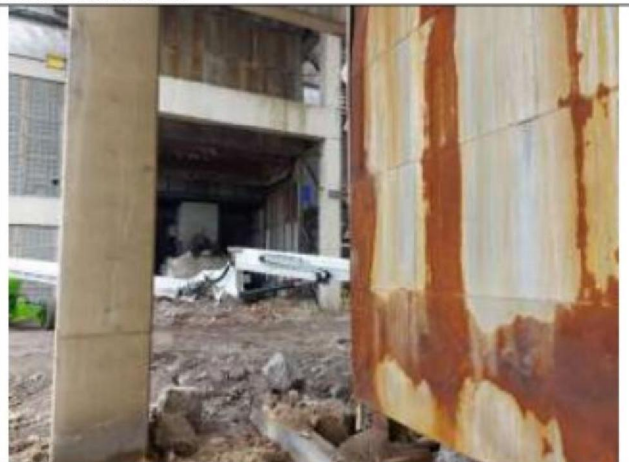
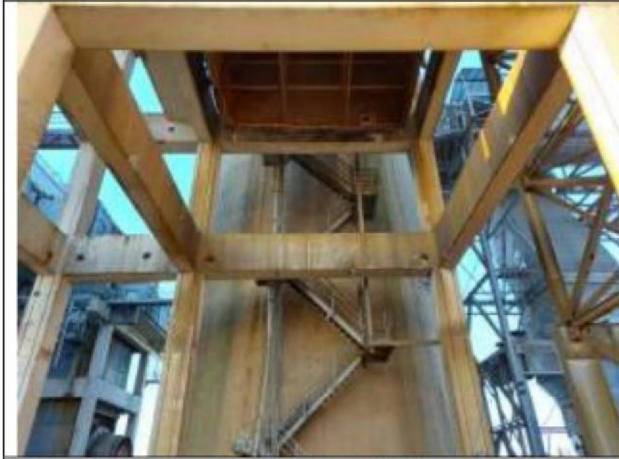
**Pictures after removal ducts and piping in the separation area**

Description photo: position ducts and piping after removal.

The parts of ducts and piping has been removed according to the MSD005. After removing we put the ducts and piping in the asbestos removal area 1. There the stamps have been removed and placed in asbestos A-vignet bags. The bags have been placed in a skip with a asbestos A-vignet containerbag.

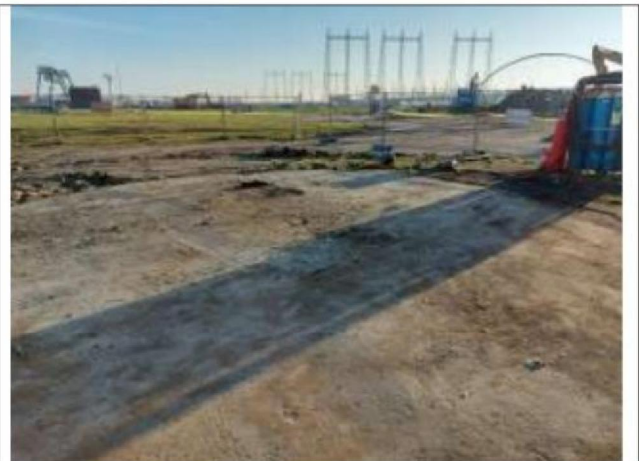
Description photo: clean concrete floor after removed the asbestos stamps and textile bandage
